**Horsefly River Riparian Restoration Project**

**Evaluation of restoration activities on the  
Horsefly River Riparian Conservation Area**

**Barry Booth  
Northern Region Manager,  
The Land Conservancy of BC  
Prince George, BC  
March, 2010**

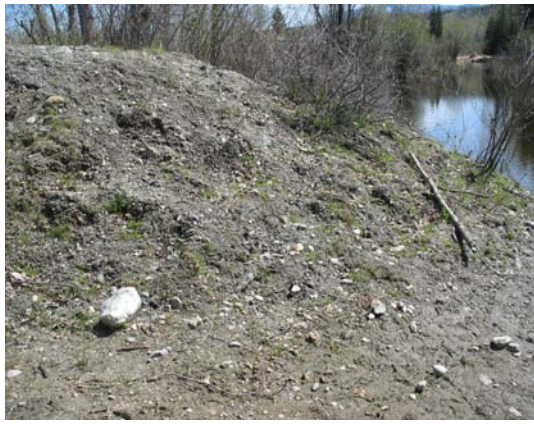
1. the amount of erosion noted at the toes of the dike was such that it was of no cause of concern,
2. the parent material of the dyke and the road bed (coarse gravel in both cases) is such that it was unlikely that erosion would be problematic in the future,
3. the flows observed at the time, although not peak flows, did not raise concerns with respect to the integrity of the toes of the dyke. When we discussed the issue of peak flows, the engineers on the team suggested that there was little cause for concern because of the two points above, and because that the velocity of the flows that would likely be encountered at peak flows would not likely to be high enough to be problematic (Figures 3-6).

Figure 3 North toe of dyke breach

The field team suggested that TLC continue monitoring of the dyke and to further efforts to re-vegetate the toe areas.

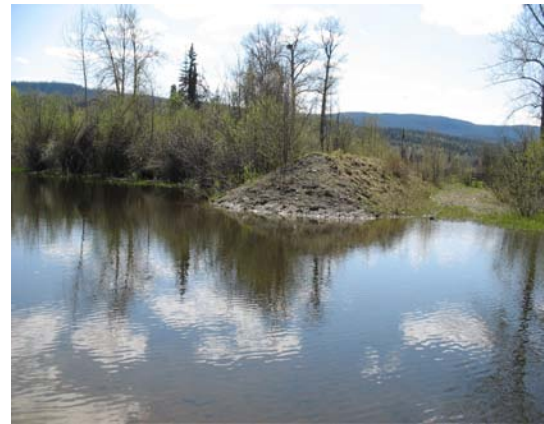
Figure 4. South toe of dyke breach

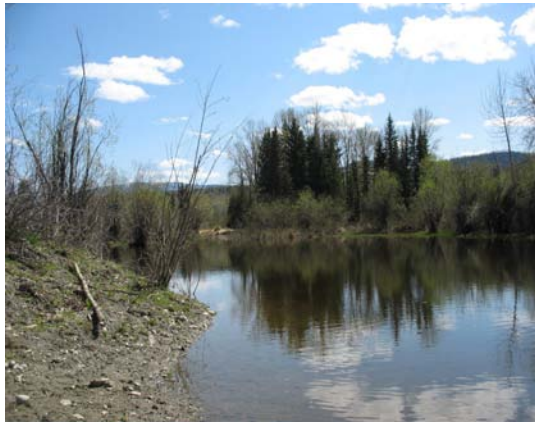
Figure 5. Looking south towards the Horsefly River

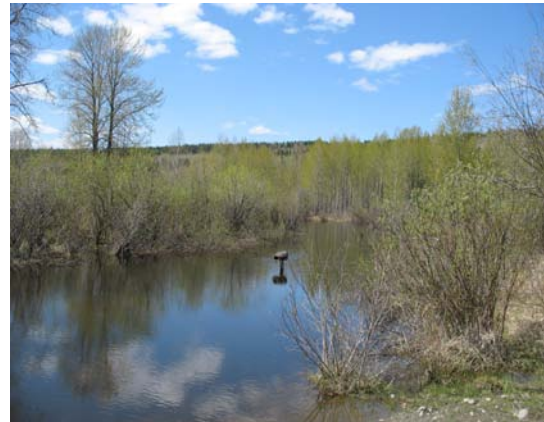
Figure 6. Looking north into oxbow

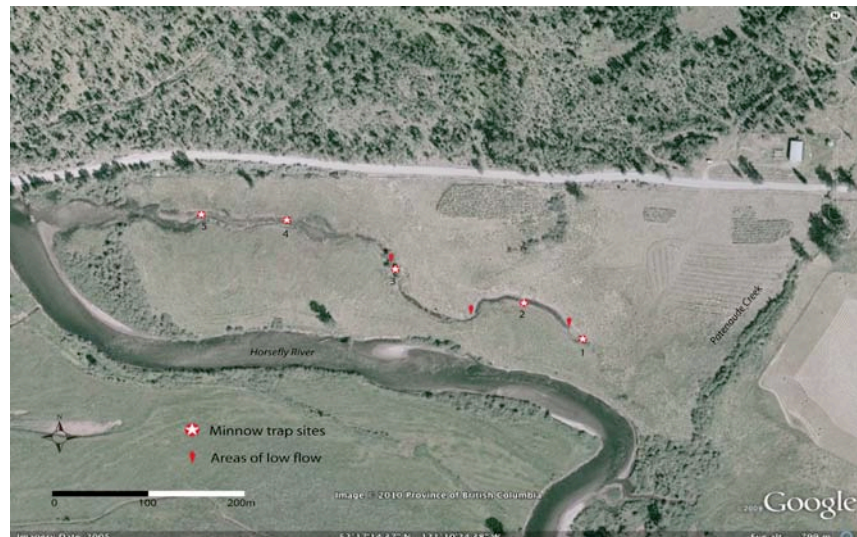
Figure 7. Location of fish traps and areas of low flow in rearing channel

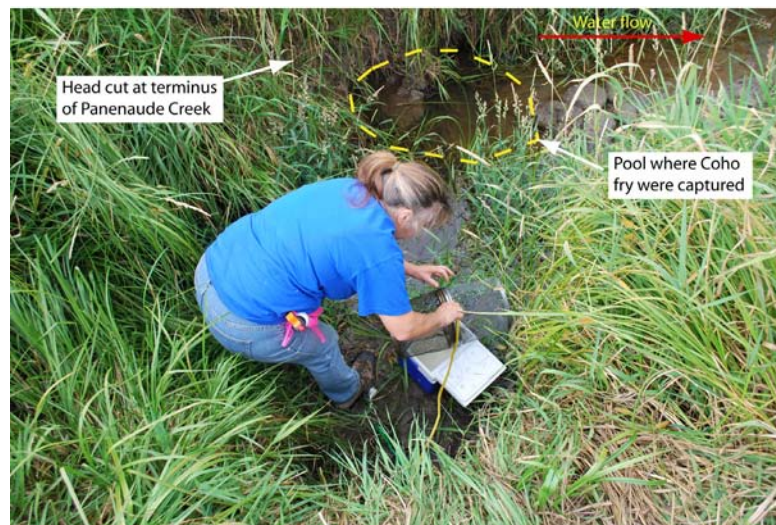
First, there is a high fish species richness in the rearing channel. This includes 3 species of salmonids (Coho, Chinook, and rainbow trout fry) as well as 3 species of adult “coarse” fish (Longnose dace, Northern Pikeminnows, and Redside shiners), and several unidentified juvenile suckers. Second, there was a high abundance of Coho fry (175 fish) at the very upstream portion of the rearing channel. These fish appeared to be trapped in a small ( $\sim 1 \text{ m}^3$ ) pool that is located where the run off from Patenaude Creek enters the rearing channel (Figure 8). The fry’s forward movement is blocked at this point by a small (50 cm) headcut or waterfall.

Figure 8. Small pool where Coho fry were caught

Based on these findings it will be important to further this monitoring situation in order to ascertain: a) do Coho fry remain trapped in the upper reaches of this structure, b) how is the rearing channel used by other species in different times of the year, and how might this affect the survival of Coho fry and, c) if this is a trap for Coho, what could/should be done to rectify this situation? This could involve some of the following efforts: trapping and moving fish on an annual basis, excavating shallow spots to facilitate movement out of the rearing channel, re-directing Patenaude Creek into the rearing channel. Some of these solutions are potentially very invasive and expensive propositions (not to mention controversial) that will require further study and broad consultation with the Department of Fisheries and Oceans, the Provincial Ministry of the Environment (original architects of the rearing channel), and fisheries

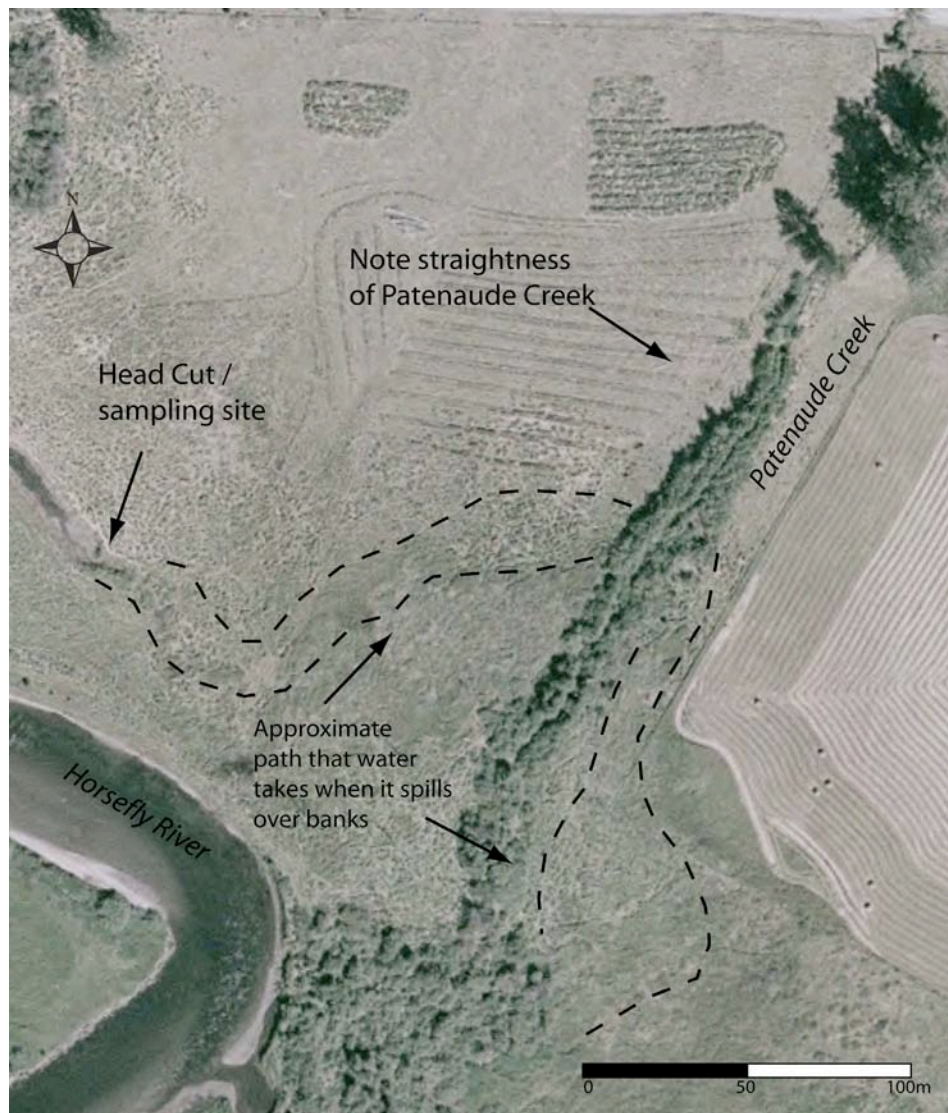
The creation of this small head cut is the result of a series of events. Prior to TLC taking ownership of this section the Horsefly River flood plain, the area was cleared for the production of hay. Part of activity associated with the clearing of the flood plain was the straightening of Patenaude Creek. It can be seen from Figures 7 and 9 that the channel of this creek is unusually straight. When one walks along this section of Patenaude Creek it is quite apparent that the creek bed has been physically straightened. Since our taking possession of the property (and likely some time before this) the creek has started to

spill over its artificially created banks and is flowing over the flood plain on both sides of the creek. On the west side of Patenaude Creek the overflow has connected up with the end of the rearing channel that was constructed in 1999. This connection has created the head cut which now represents a barrier to the upstream movement of juvenile Coho that find themselves in the rearing channel (Figure 9).

Figure 9. Dynamics of Patenaude Creek

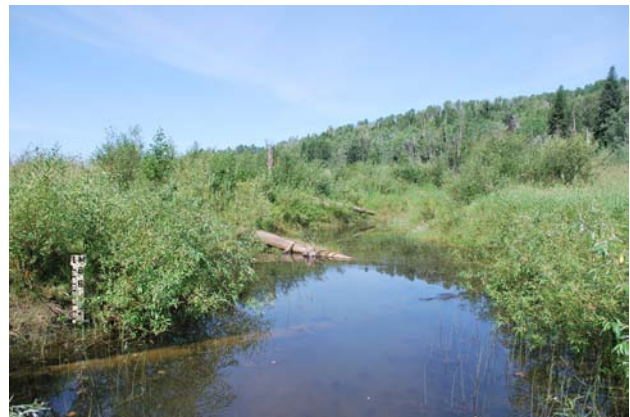
It should also be noted that the restoration work in this area of the Conservation Area has been extremely effective. Willows that were planted along the rearing channel have become well established along most of the rearing channel (Figures 10 and 11).

Figure 11 A section of the rearing channel in 2009

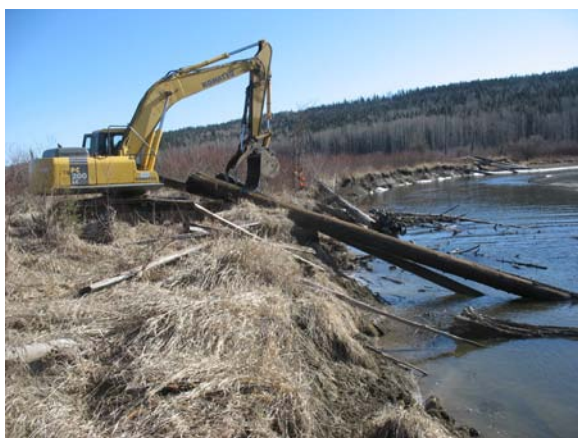
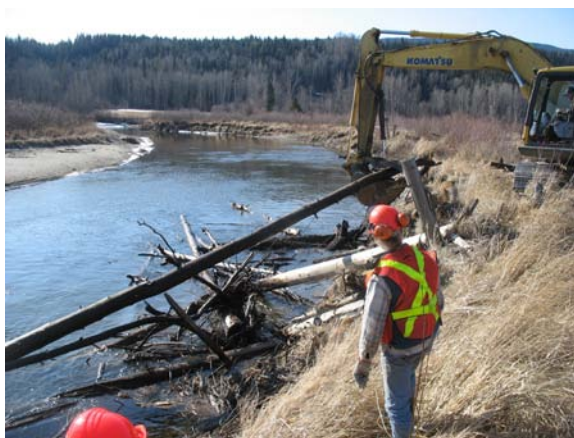
Figure 12 and 13. Removing debris catchers along the main stem of the Horsefly

With funds from the BC Ministry of Transportation, a crew of 5 met at the debris catcher site on March 6, 2010 to dismantle the debris catchers. This included an excavator operator, a professional chain saw operator, Richard Case, restoration ecologist, Judy Hillaby from DFO and myself. Each debris catcher was examined and all but 3 were dismantled. This involved the removal of any logs from the river that were cabled together and/or were cabled to the foreshore. We left debris in the river that we felt posed no risk to down stream habitat. Logs that were removed from the river were placed on high points of the bank that are not subject to flooding and cables were removed from them. In two areas we actively transported logs to upland areas in the vicinity of the debris catchers. We also “planted” one particularly long log as a snag (Figures 12-16). Because the ground was still frozen and because of the expertise of the excavator operator, minimal disturbance to the river bed and to the foreshore was noted. Permanent monitoring sites will be established to monitor bank movement and stability in areas where debris catchers were both left and removed.

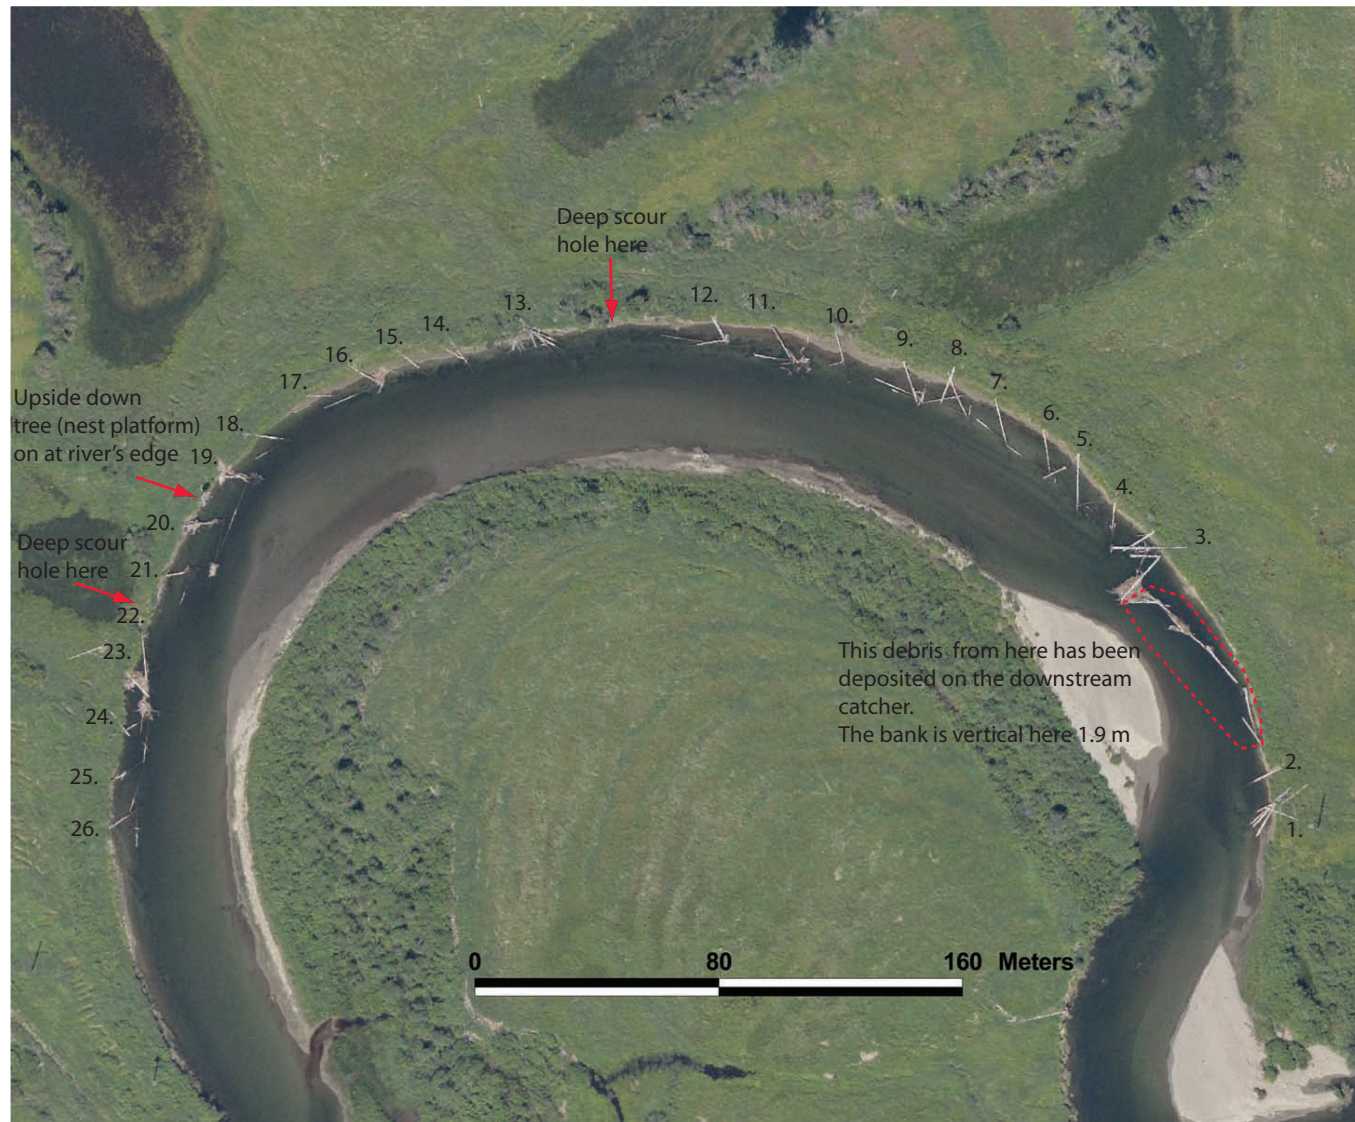
| 1. No functioning pins, five logs cabled together here | 14. Upslope pin 5 m from river's edge, downslope pin 1.5 m from river's edge |
| 2. No functioning pins, deflector embedded in river bottom | 15. Upslope pin 7 m from river's edge, downslope pin 3 m from river's edge |
| 3. No functioning pins, all debris upstream deposited here | 16. Upslope pin 4.5 m from river's edge, downslope pin 1.5 m from river's edge |
| 4. No functioning pins, deflector in water | 17. Both pins in place, deflector has floated up over top of pins and is on shore |
| 5. No functioning pins, deflector on bank | 18. Upslope pin 3 m from river's edge, downslope missing, bank vertical here - 2m |
| 6. Upslope pin on shore, actively being scoured at base | 19. All material gone from here |
| 7. Upslope pin at waters edge, actively being scoured at base | 20. Upslope pin on river's edge, downslope missing |
| 8. Upslope pin at waters edge, actively being scoured at base | 21. All material gone from here |
| 9. Upslope pin at waters edge, actively being scoured at base | 22. Both pins gone, deflector on shore |
| 10. No functioning pins, debris catcher in water | 23. Both pins gone, deflector in water |
| 11. Upslope pin 3.5 m from shore, bank vertical here .7m | 24. Upslope pin 1.5 m from shore, downstream pin gone, debris catcher in water |
| 12. No functioning pins, deflector in water | 25. Upstream pin on river's edge, downstream pin gone, debris catcher in water |
| 13. Upslope pin on river's edge, downslope pin in channel | 26. Both pins gone, deflector in water |

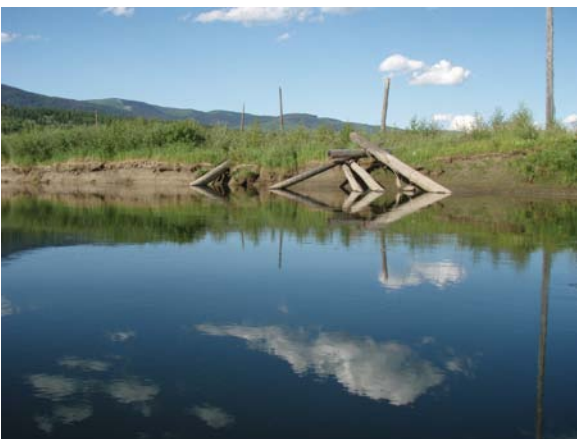
Aggregation of debris at location 1.

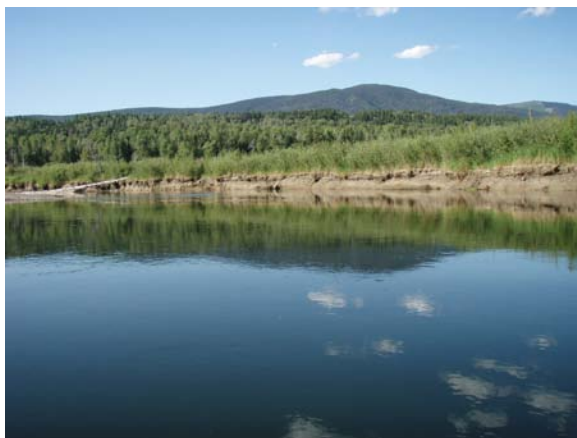
Vertical bank between locations 1 and 2.

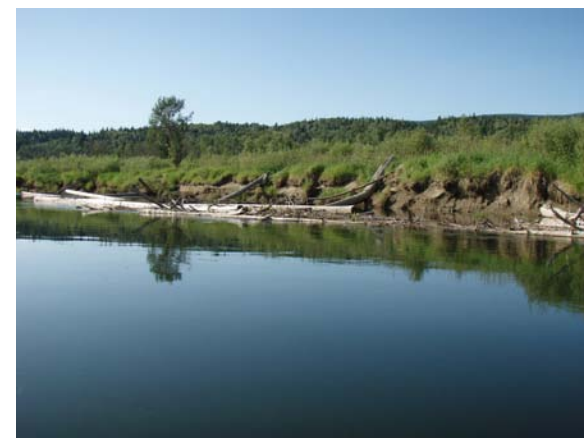
Debris at location 3.

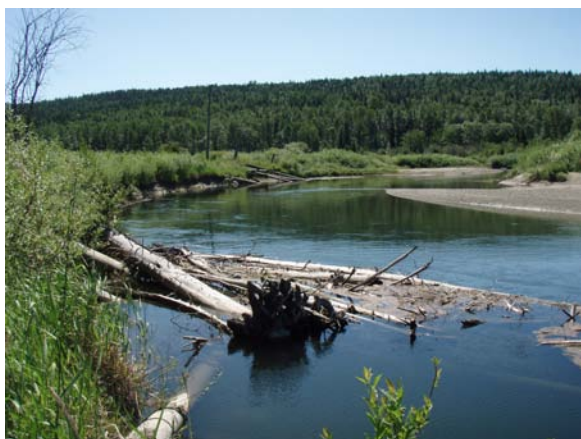
Debris at location 3, from downstream.

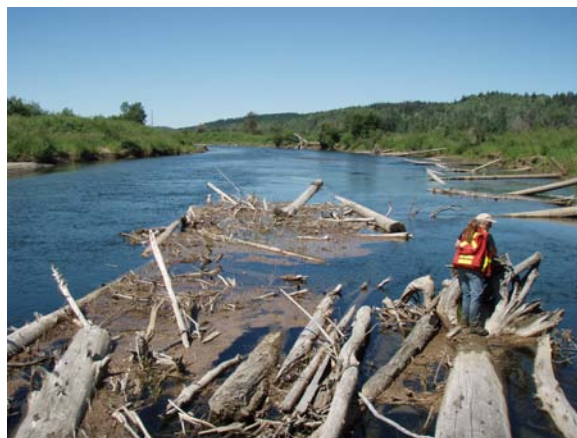
Debris at location 3, note logs cabled together at downstream end of debris pile.

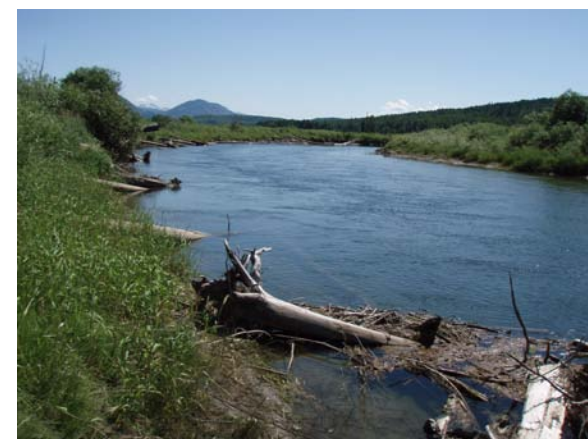
One of few places where debris catchers are still functioning, note slope of bank and regeneration of willows - at location 14-16.
