Bonaparte Watershed Restoration Project: As-Built Summary, April, 2011

Project Overview

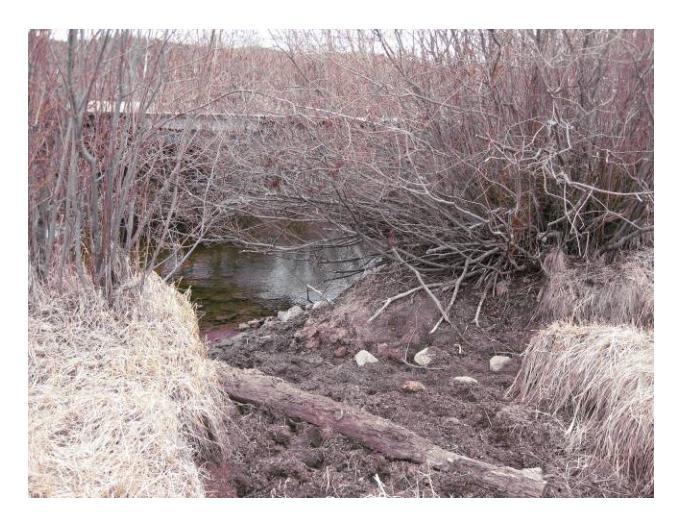
Pre-Construction Photo Site 12

Site 12 is located on the Bonaparte River near Eagan Sharpe Lake Road east of 70 Mile House BC (10U 652523 5688675 (immediately upstream from the farm bridge on the right bank). The site has been frequented by livestock as a stream crossing location and damage to the riparian vegetation and riverbank had occurred. The landowner requested that cattle access be eliminated using rock barriers, rather than upgrading the site as a limited access watering location, to discourage livestock access.
