# Fraser Salmon & Watersheds Program

## 2008 Final Report Template

**Silverhope Creek Mainstem Restoration**

Silverhope Creek - Approximately 16km south of the town of Hope, BC.

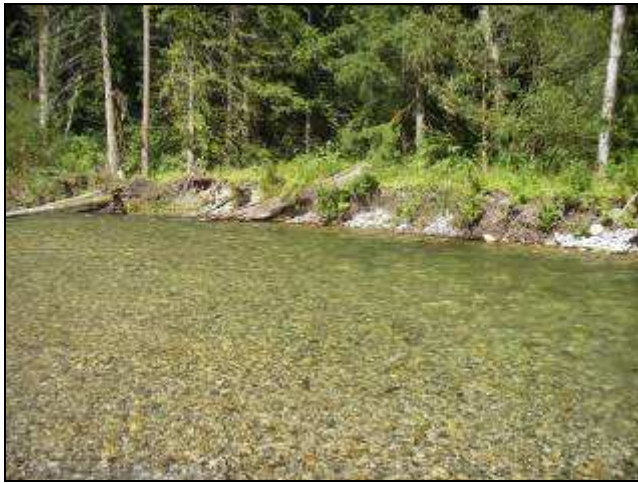
Pre-construction, eroding stream bank.

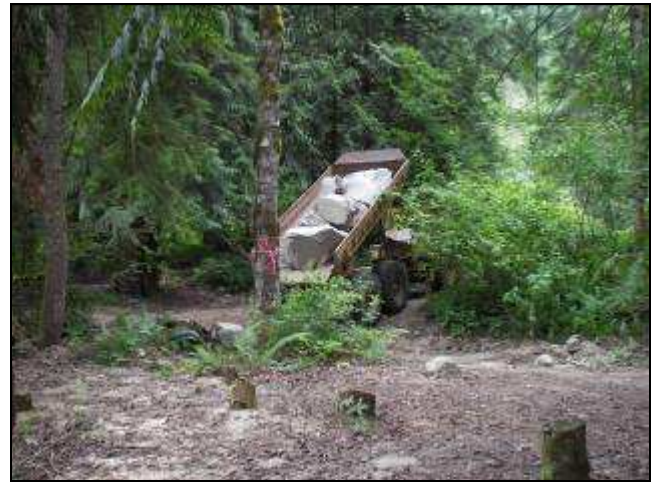
Off-loading rock; used as bank protection, or as ballast material to hold the wood structures in place.

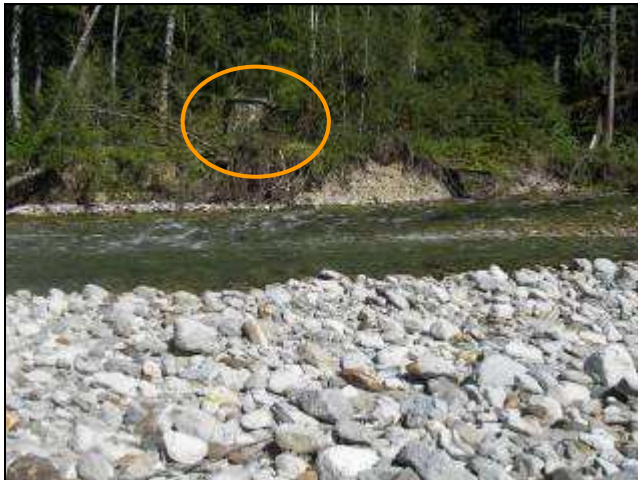
Pre-construction eroding stream bank. Note the size of a tree stump which once protected the bank.

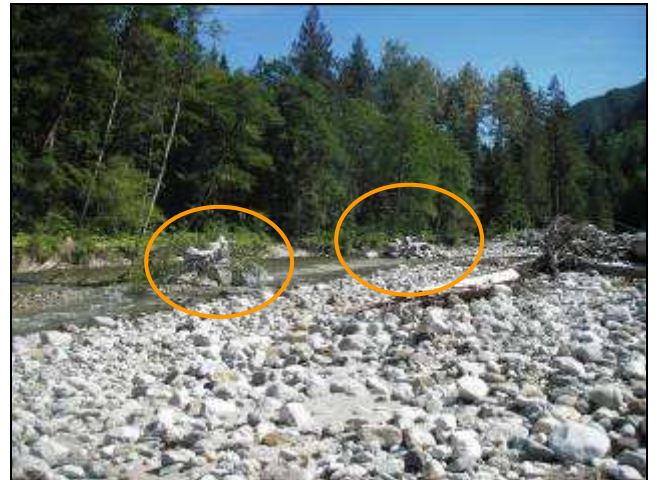
Staging material adjacent to the sites where installation of the wood structures is to take place.

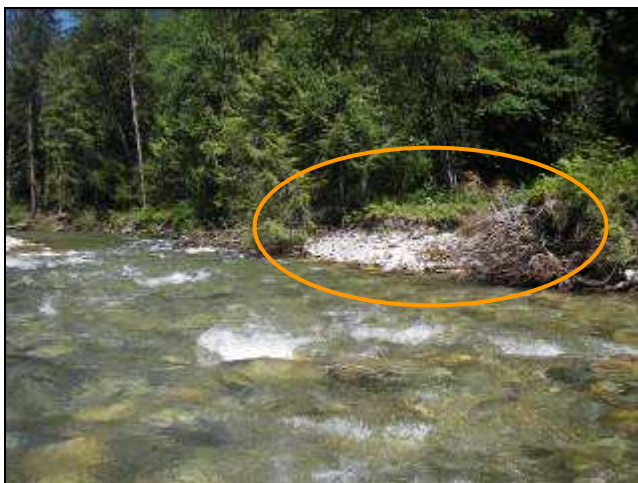
View of the downstream end of the over-flow channel where it re-enters the mainstem.

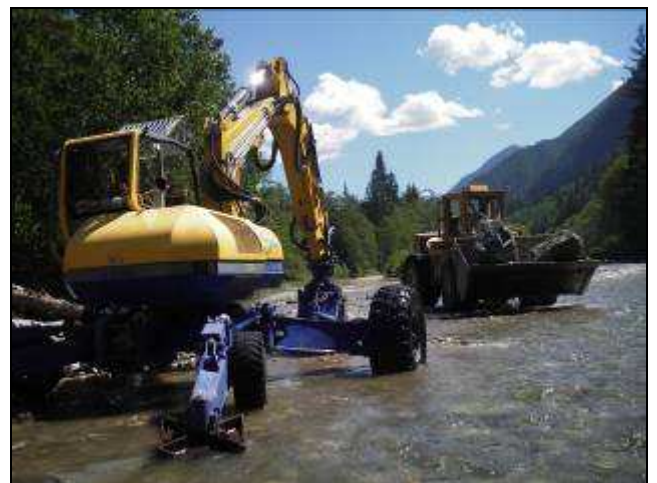
Heavy machinery working in tandem.

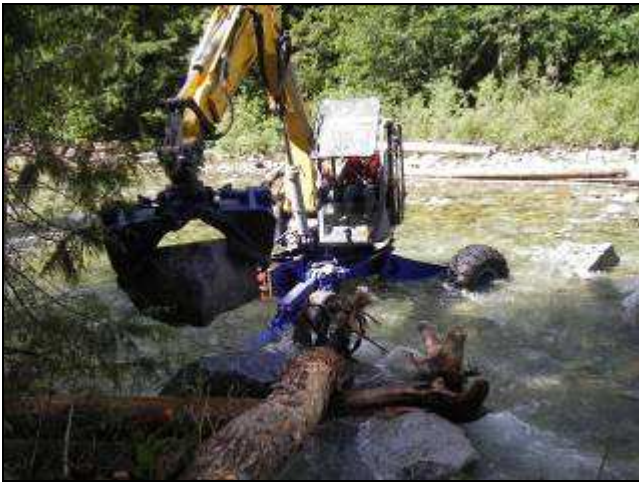
Construction of the wood habitat structures using the environmentally sensitive spyder excavator.

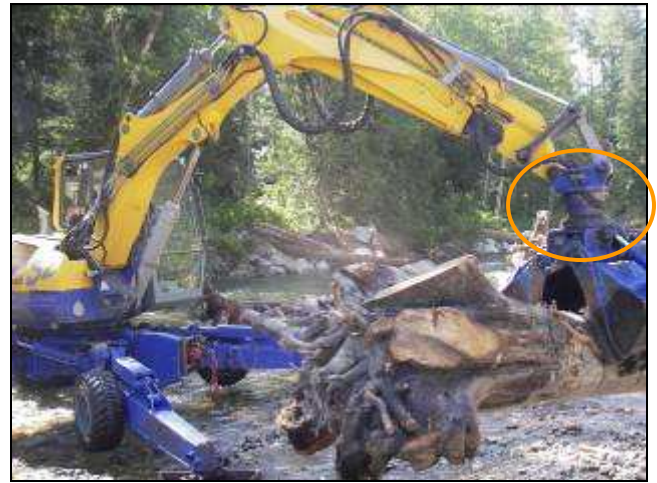
This “clam shell” style grapple/bucket has a swivelling head, allowing for greater manoeuvrability and precision with wood and rock placement.

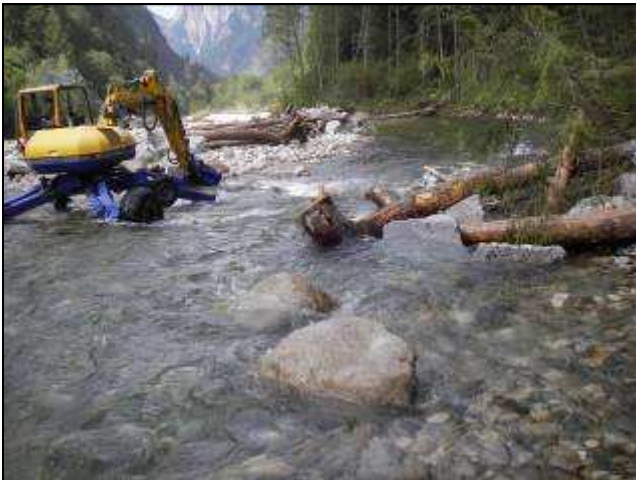
Balloon tires reduce compression of the stream bed.

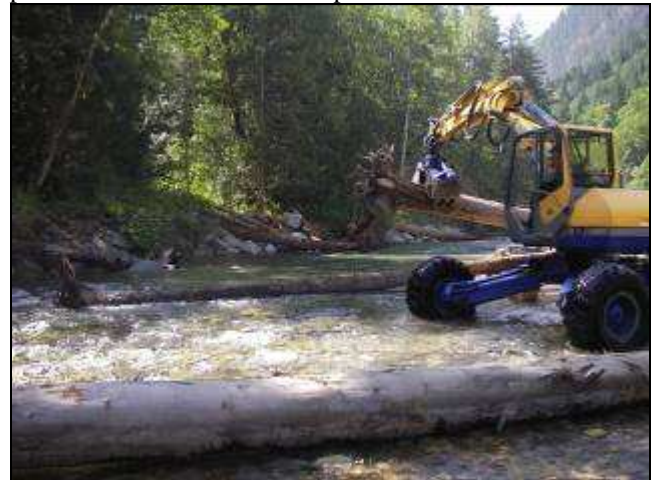
Biodegradable vegetable based lubricants are used in place of harmful petroleum based products.

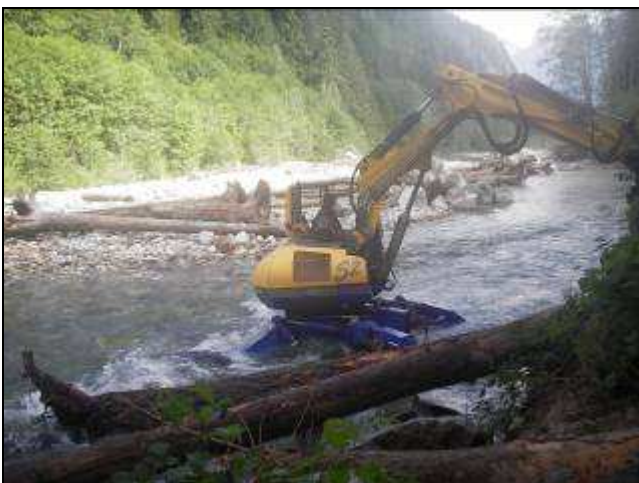
Capable of working in extremely deep waters.

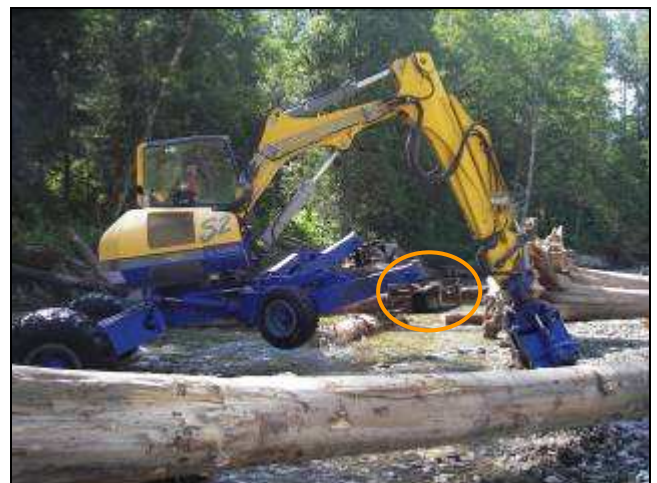
Flat pads on the front appendage prevents compression of the stream bed.

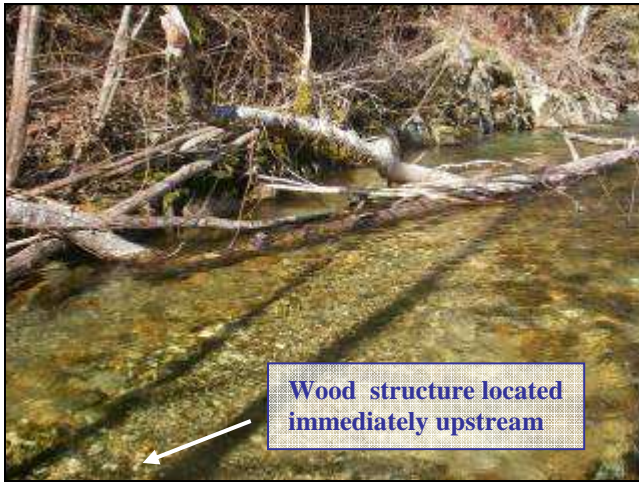
Gravel deposition behind one of the wood structures that will be suitable for adult spawning.

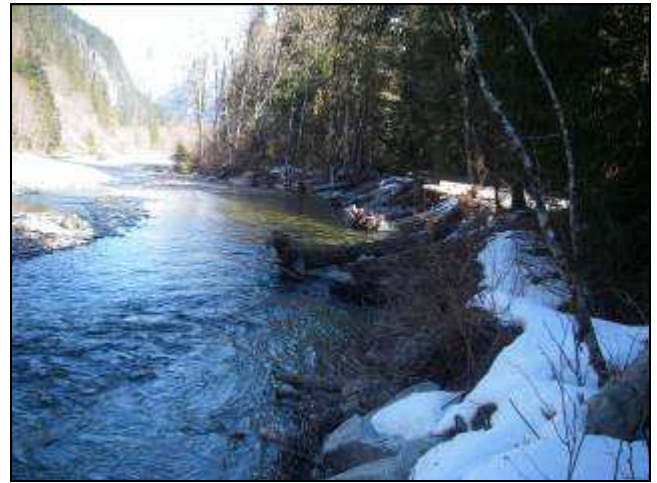
View looking downstream of the protected bank (March, 2009)

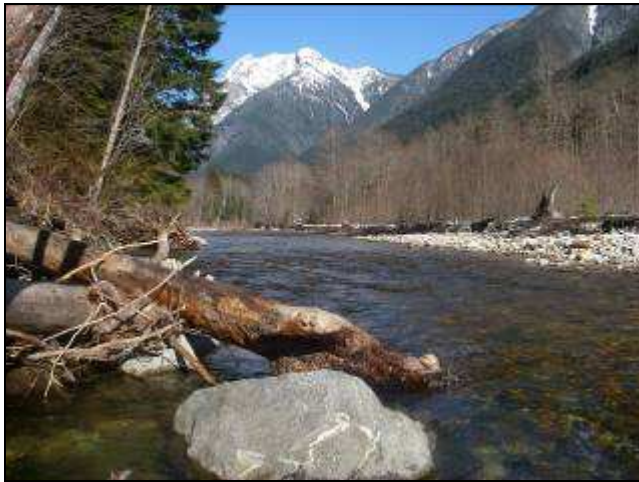
A wood structure which was constructed this past summer, that is beginning to collect drift wood.

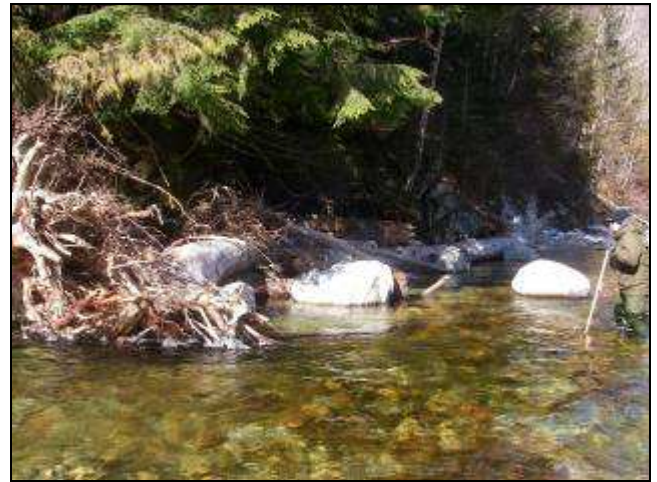
View looking downstream on a parallel wood structure which has a tree lodged against it (March, 2009).

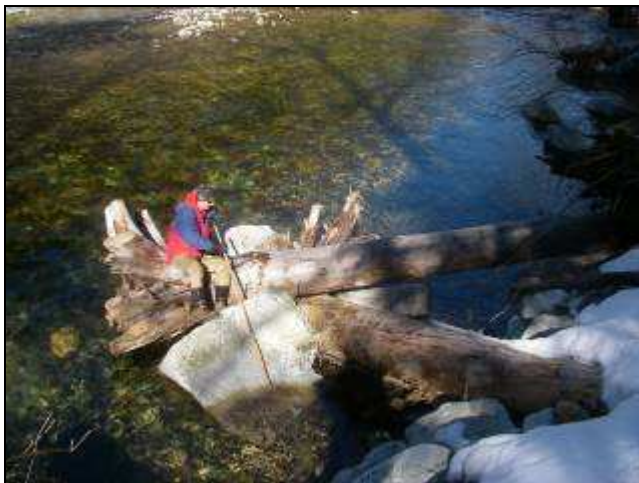
Conducting a wood structure and habitat condition inspection prior to the expected April/May freshet.

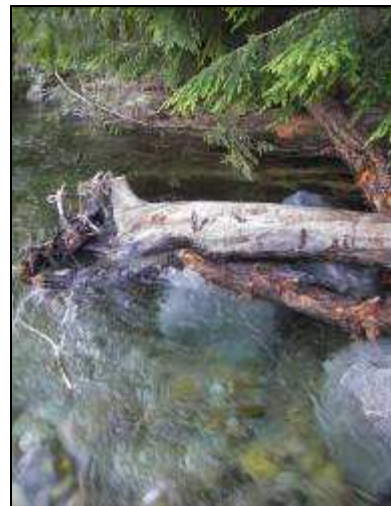
View looking from above, on a portion of the parallel wood structure.

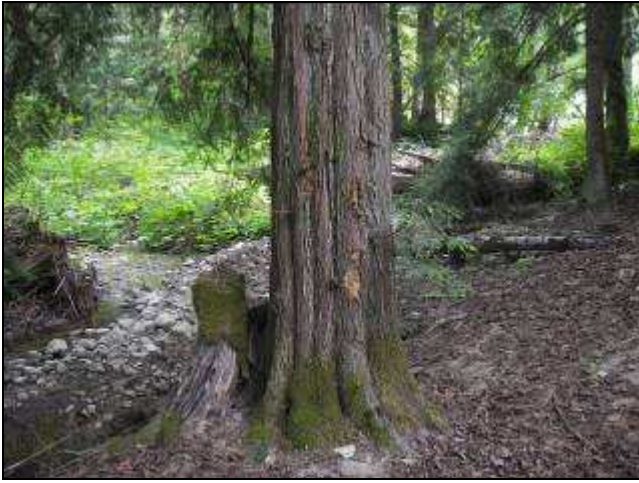
Vandalism to a live, mature cedar tree at a roadside campsite.

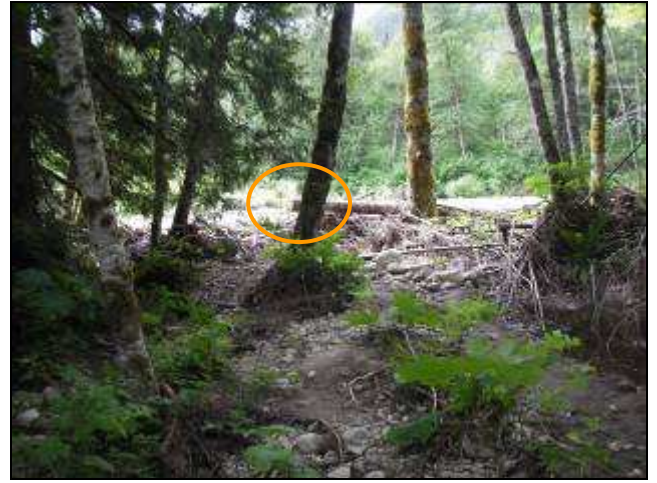
Upstream end of the over-flow channel which is cutting through the forest. Evidence of tree cutting is shown.

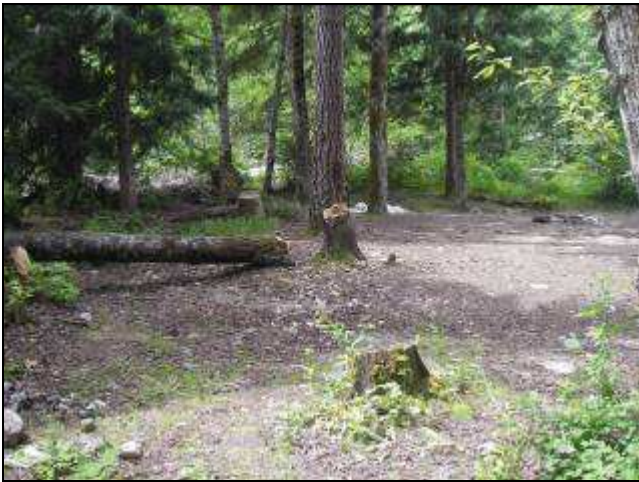
Remnant trees stumps exist as a result of campers cutting live trees.
