*Tsecmenú'ecwem-kt
(We Repair the Land)
Deadman Watershed Recovery &
Resiliency Initiative*

Overview

Assessing post-wildfire response of the Deadman River watershed before and after treatment measures using adaptive management

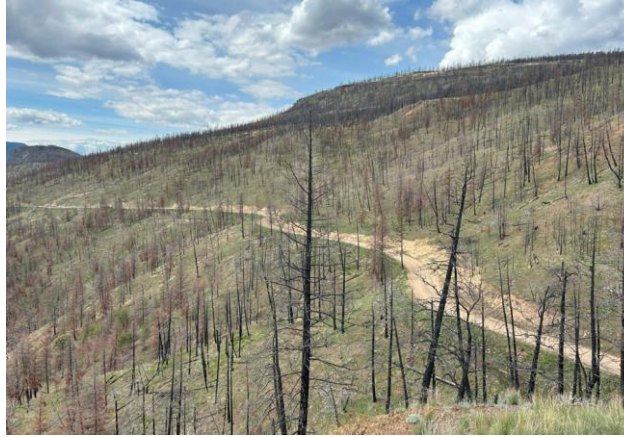
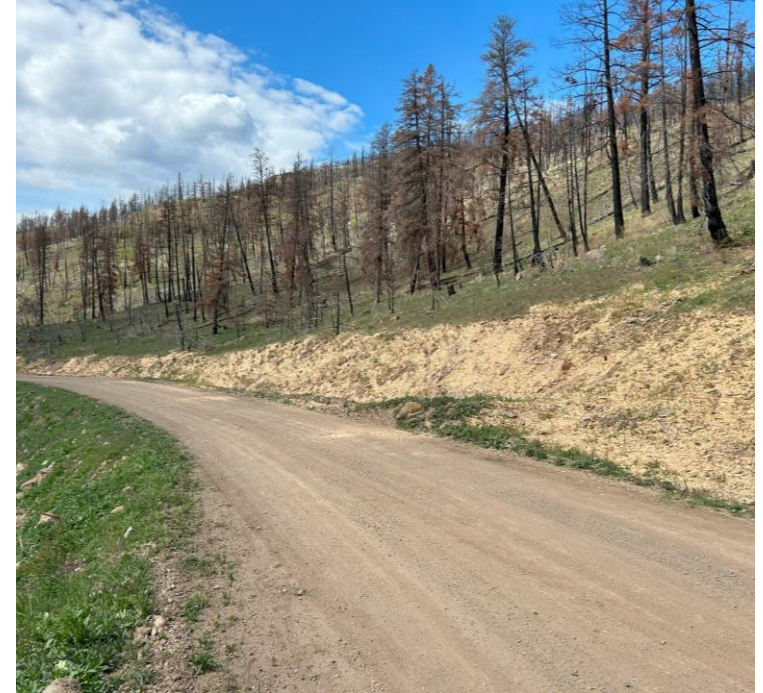
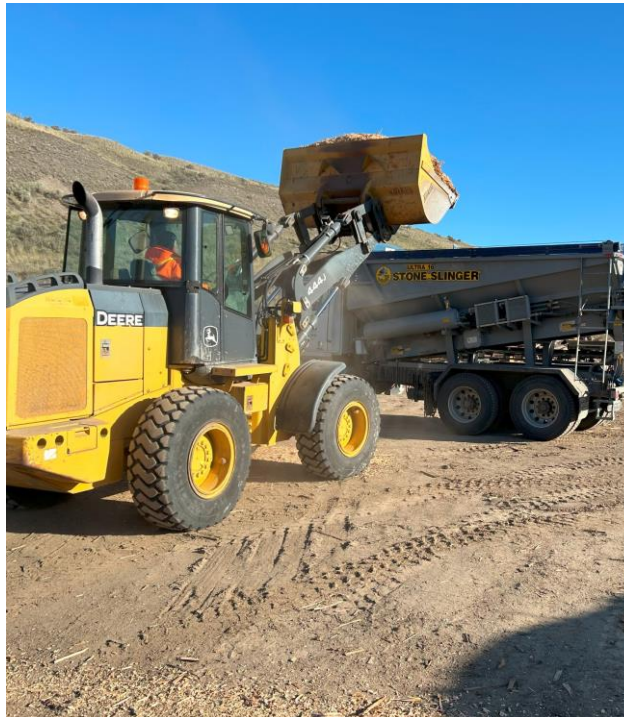
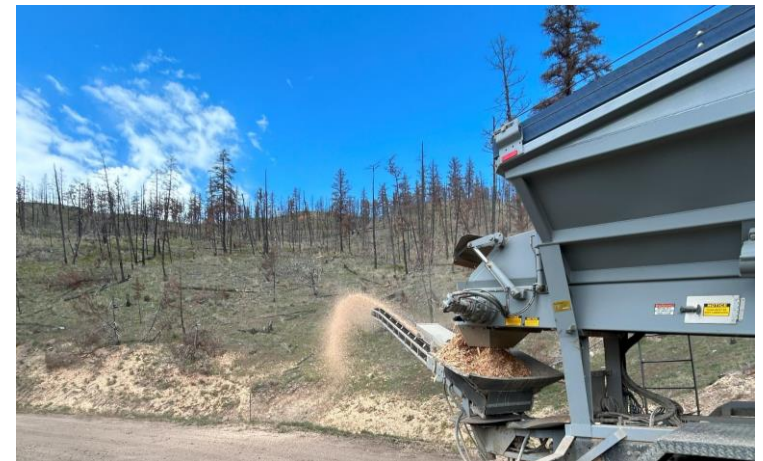
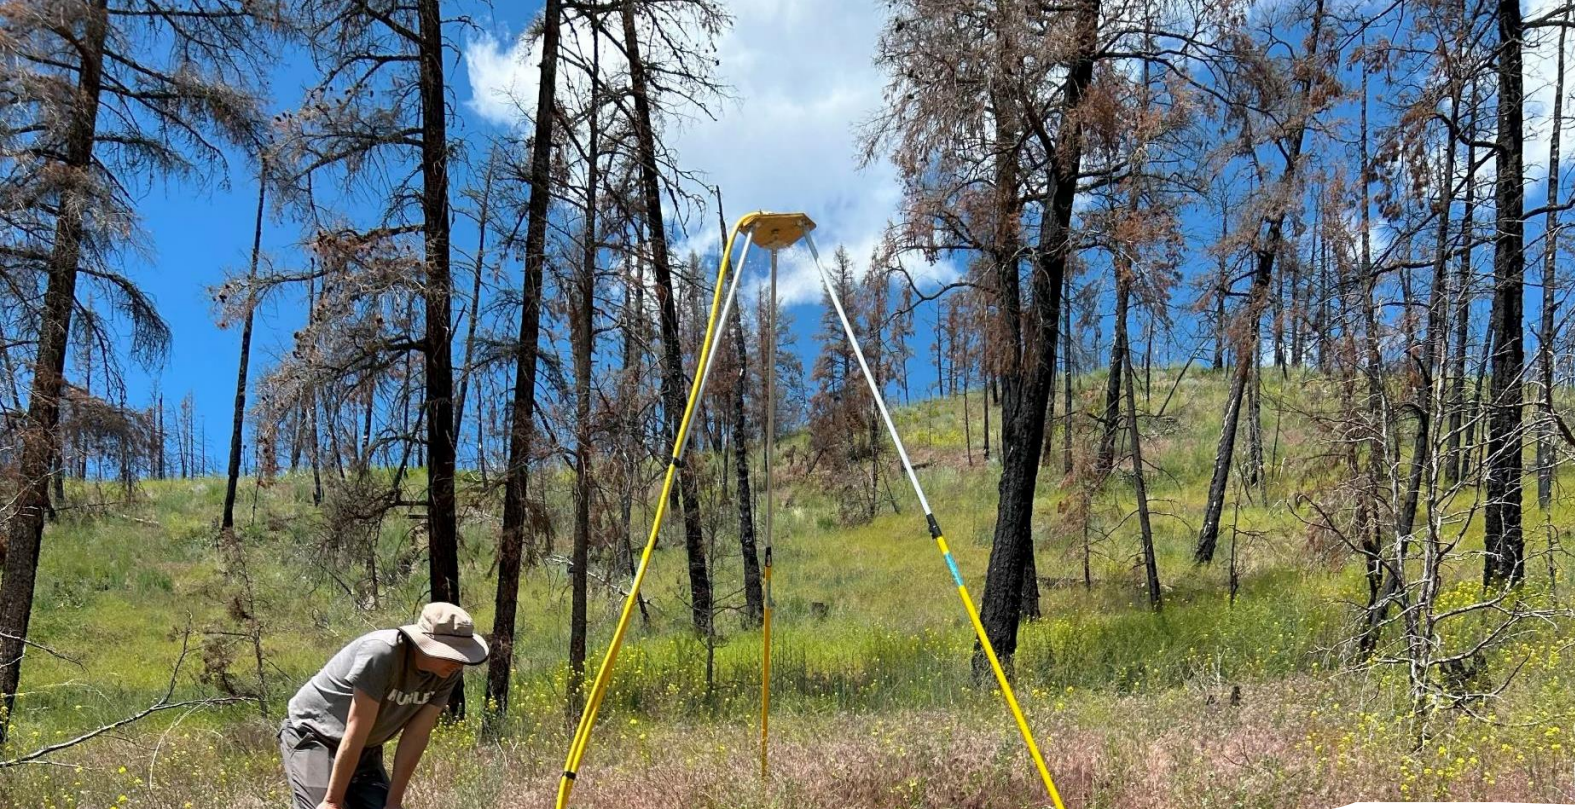
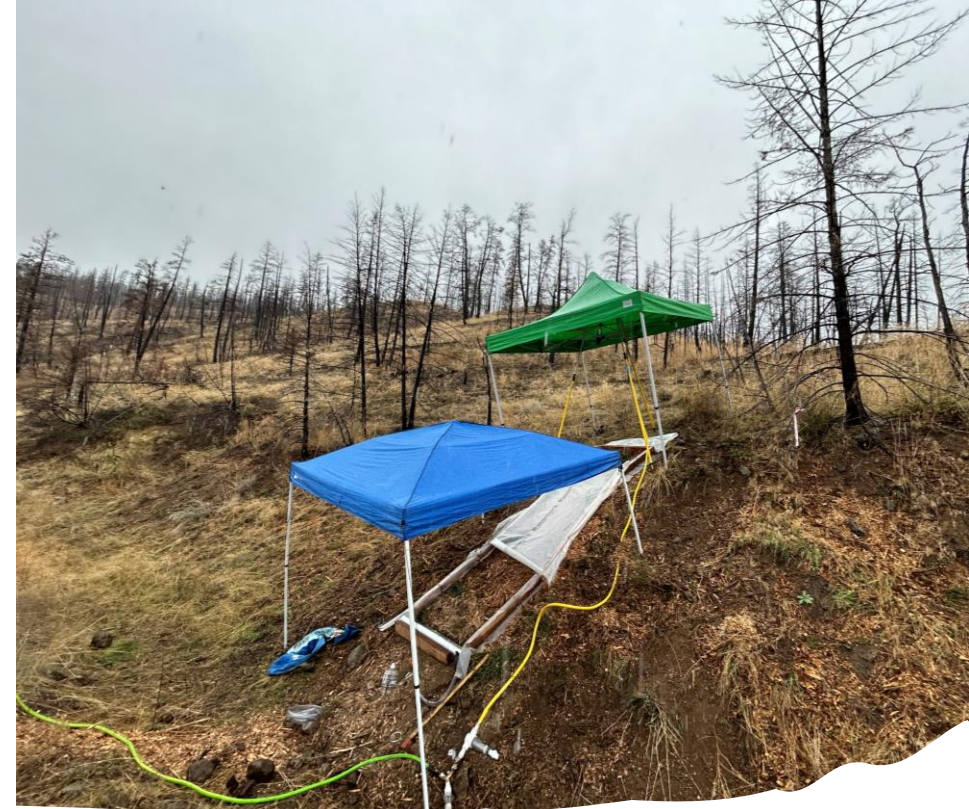
Mulch Strip Application

- 400-meter stretch treated along Criss Creek FSR (5400 Rd)
- Target coverage >70% and a minimum 3-meter width

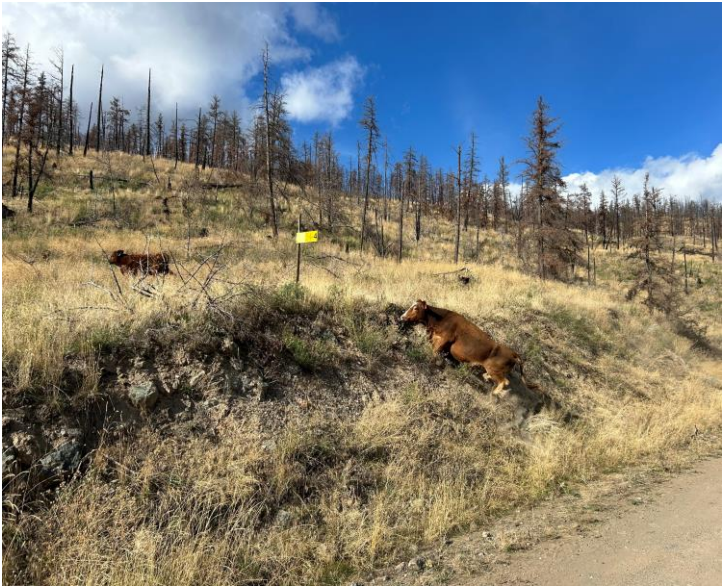
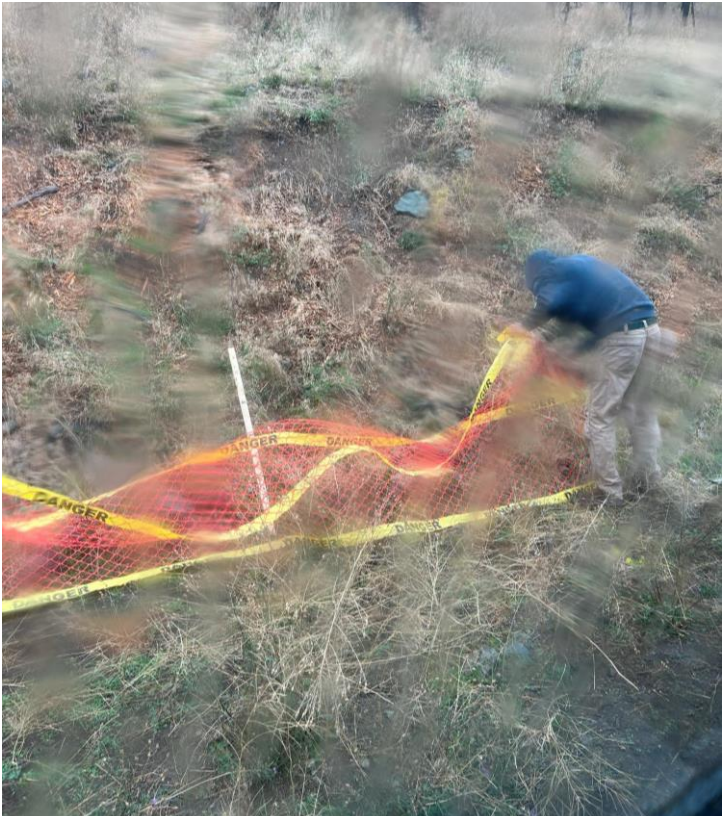
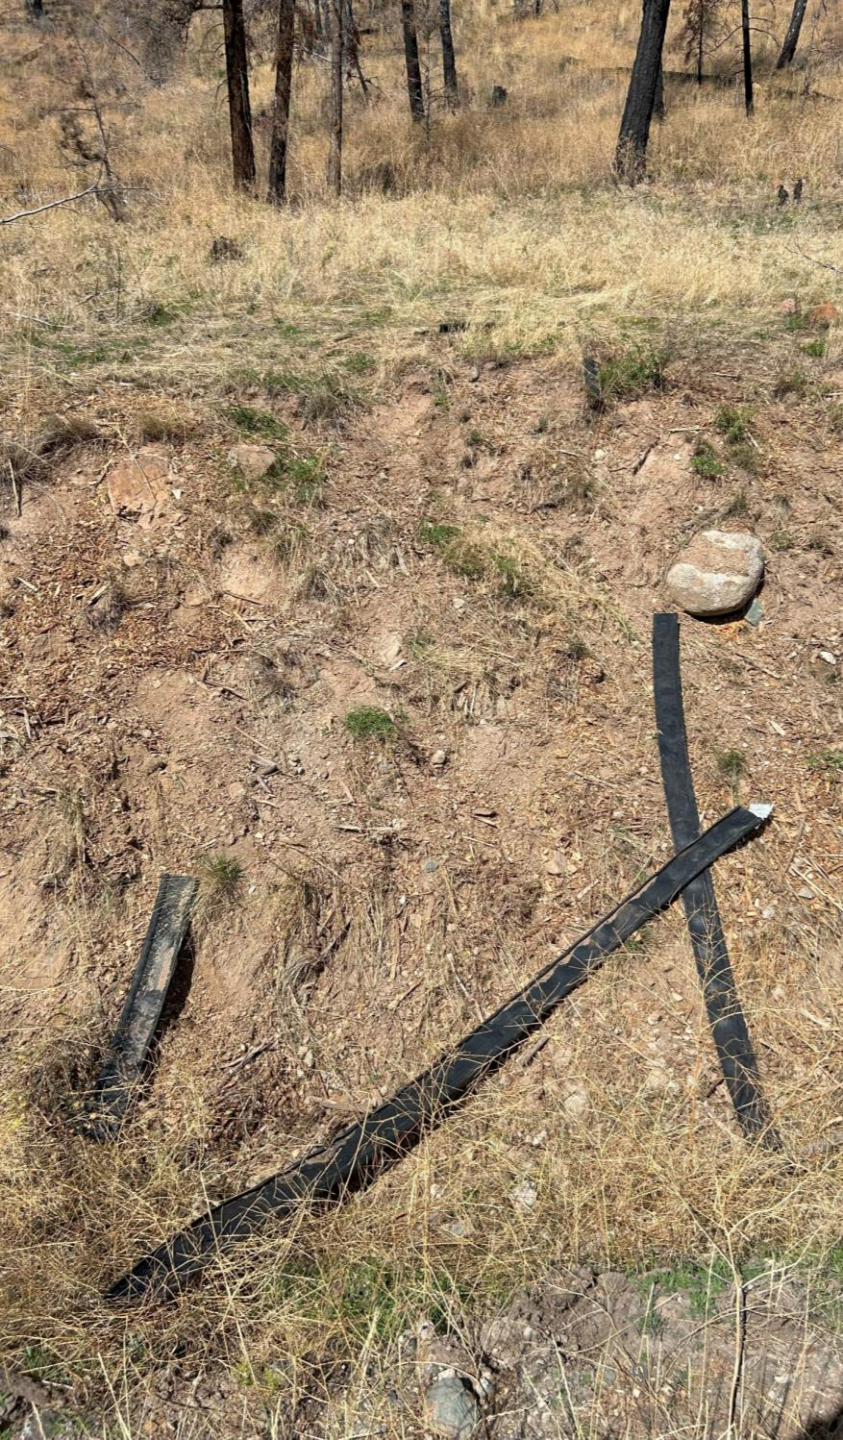
Trials

Troubles...

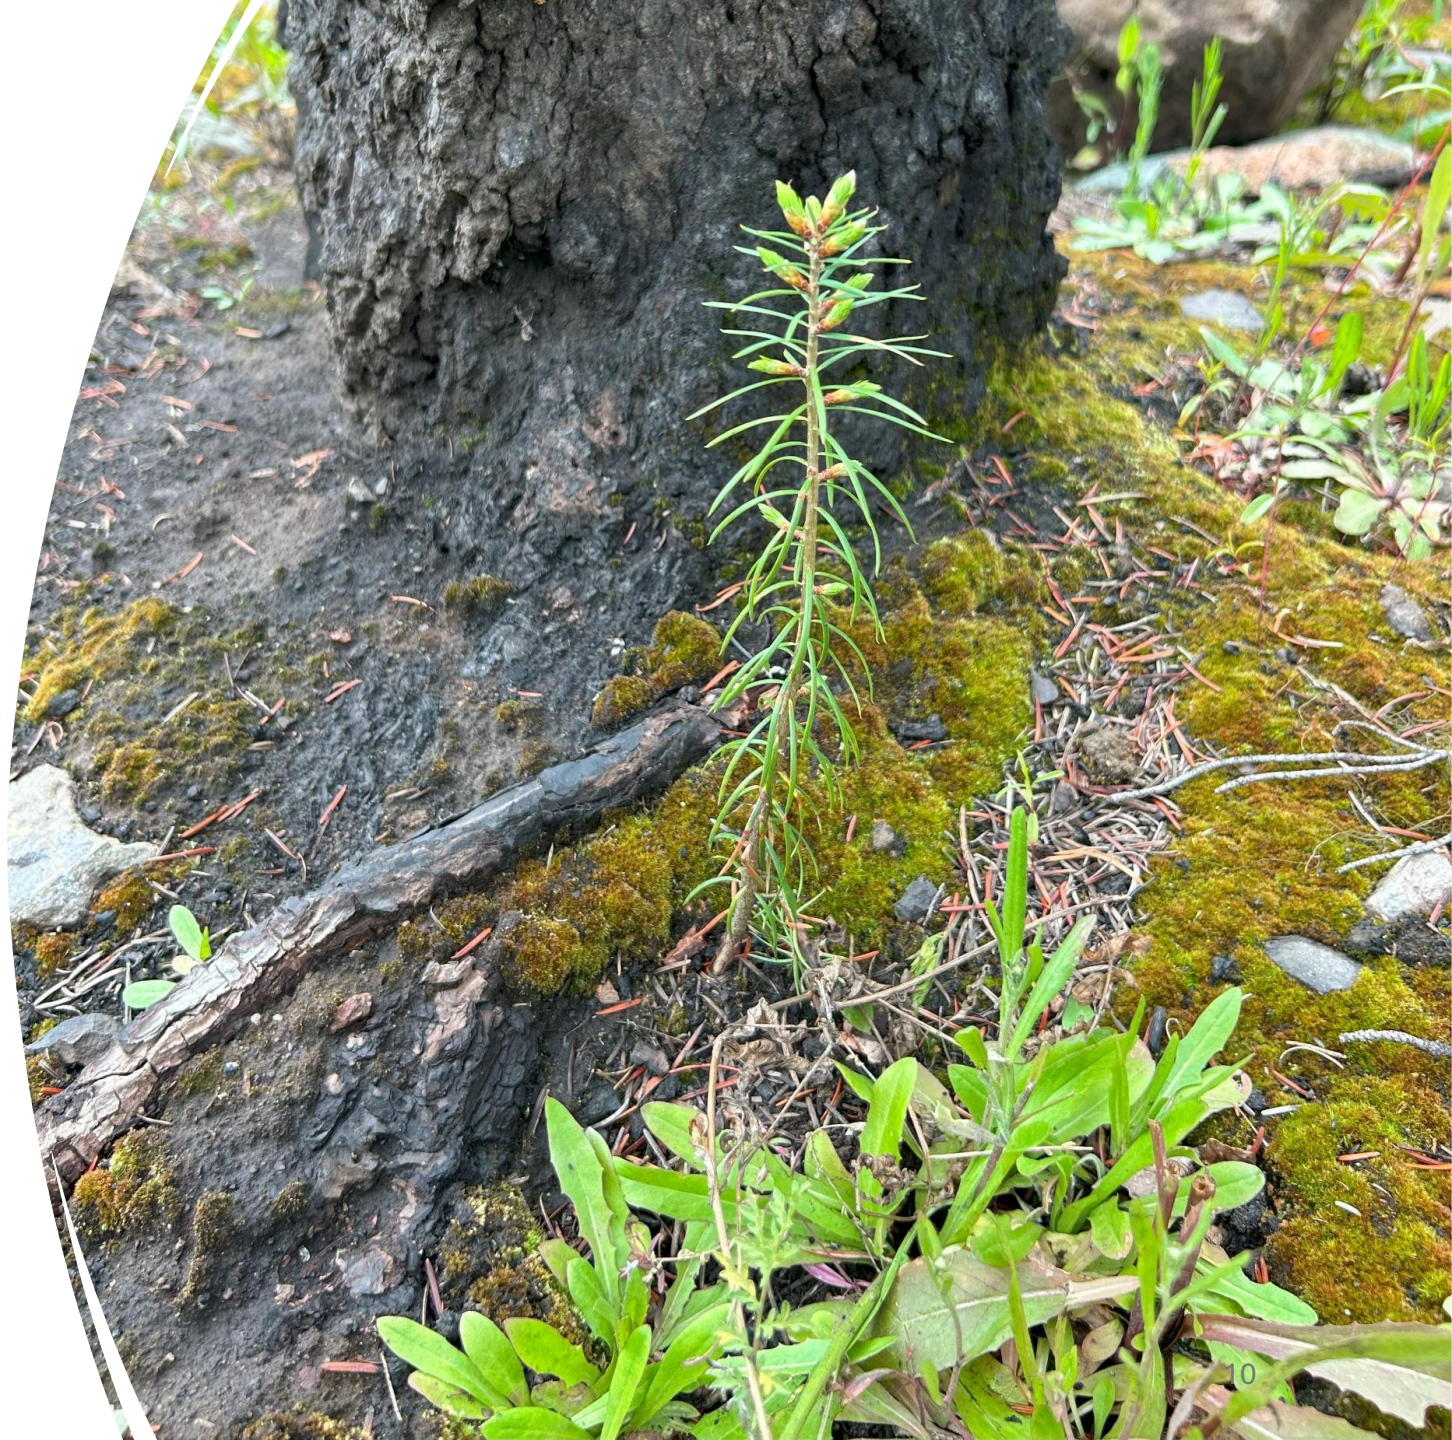
Reforestation

- 10.5 Million trees planted by 2031 through 2 Billion Tree Program
- Underplanting in areas of high burn severity
 - Using burnt trees as obstacles
 - Fertilizer bags
- 1.85 Million planted so far, 2.9 Million sown for next spring

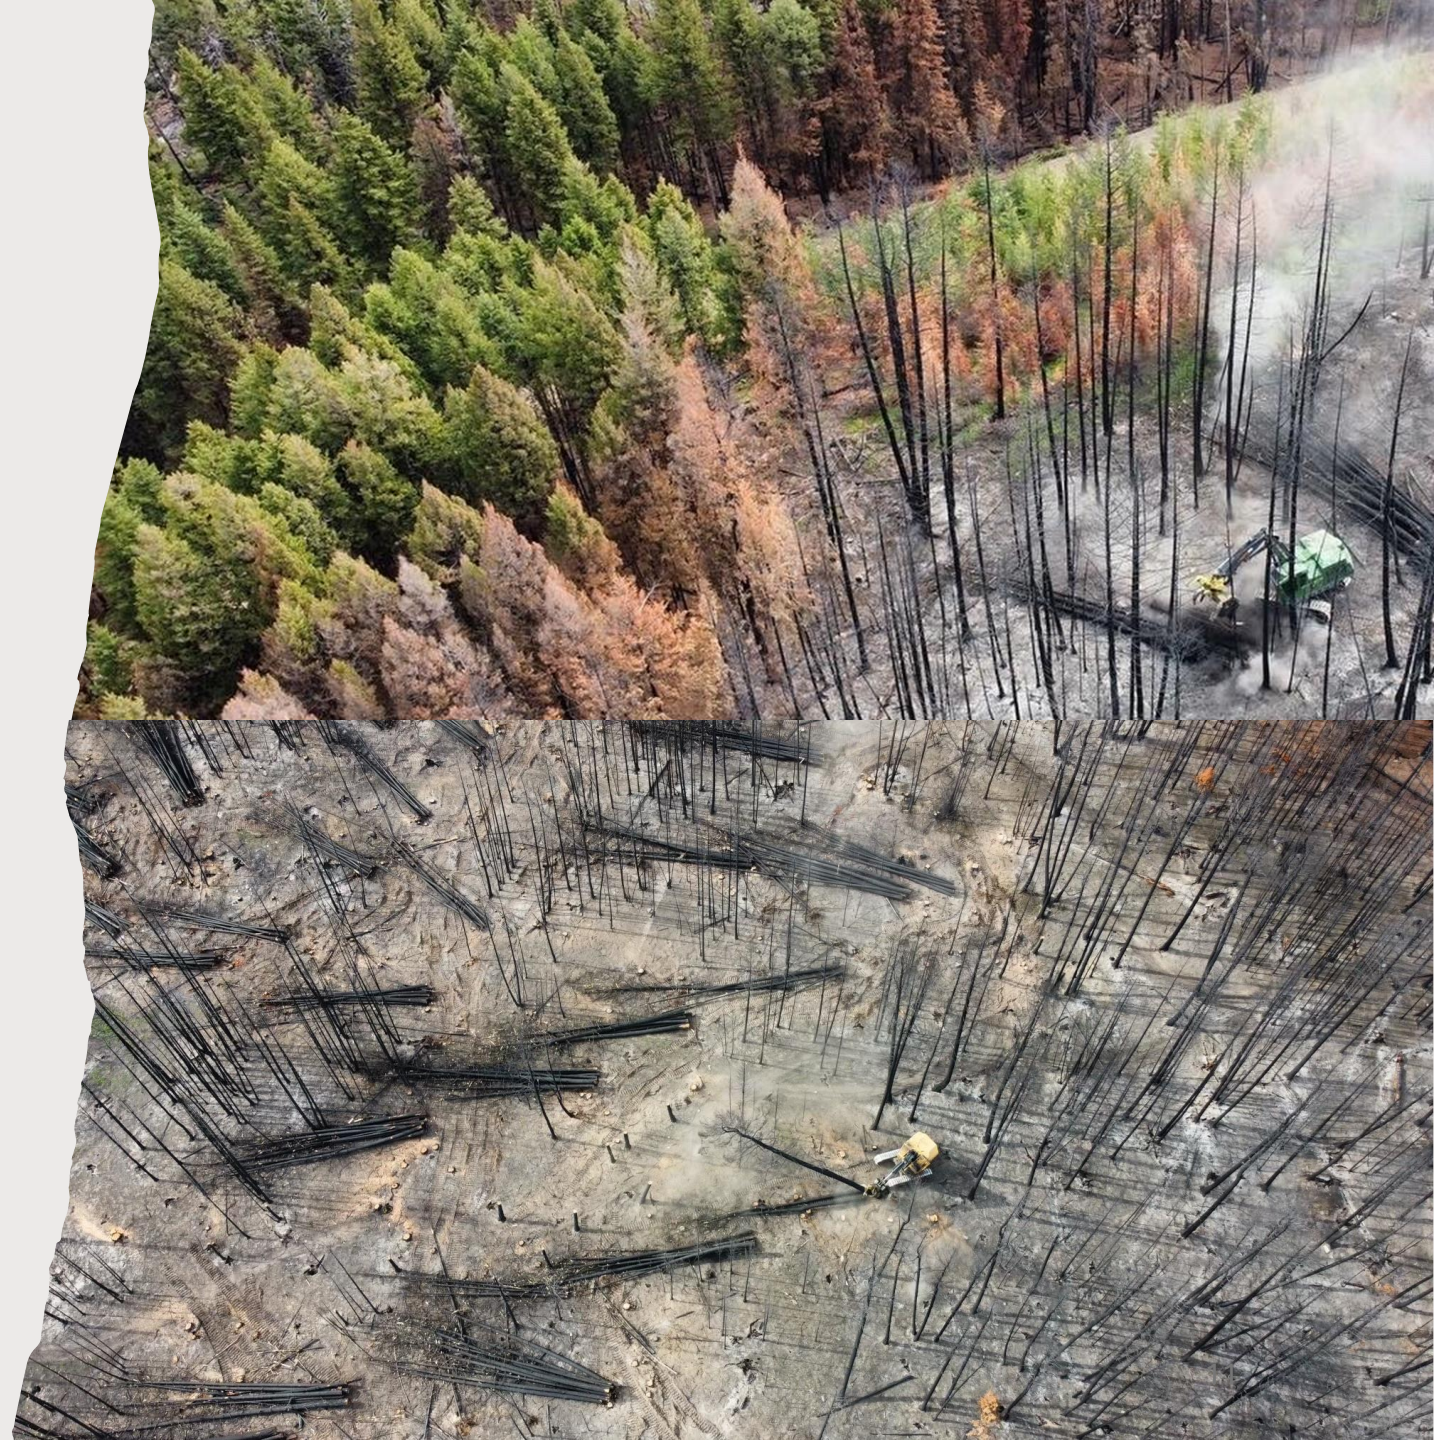
Salvage Harvesting

- Prescriptions follow Skeetchestn developed Wildfire Salvage Guidelines
- Combination of obstacle planting and traditional site prep methods
- Distribution patterns
- Fibre Utilization
