Restoring Watershed Resilience

“Rewetting the Sponge: Using the Umatilla Tribe’s River Vision to restore resilience in the Tucannon sub-basin”

Kris Fischer, Tucannon Basin Fish Habitat Enhancement Project Lead

Tucannon PA-27/28.1

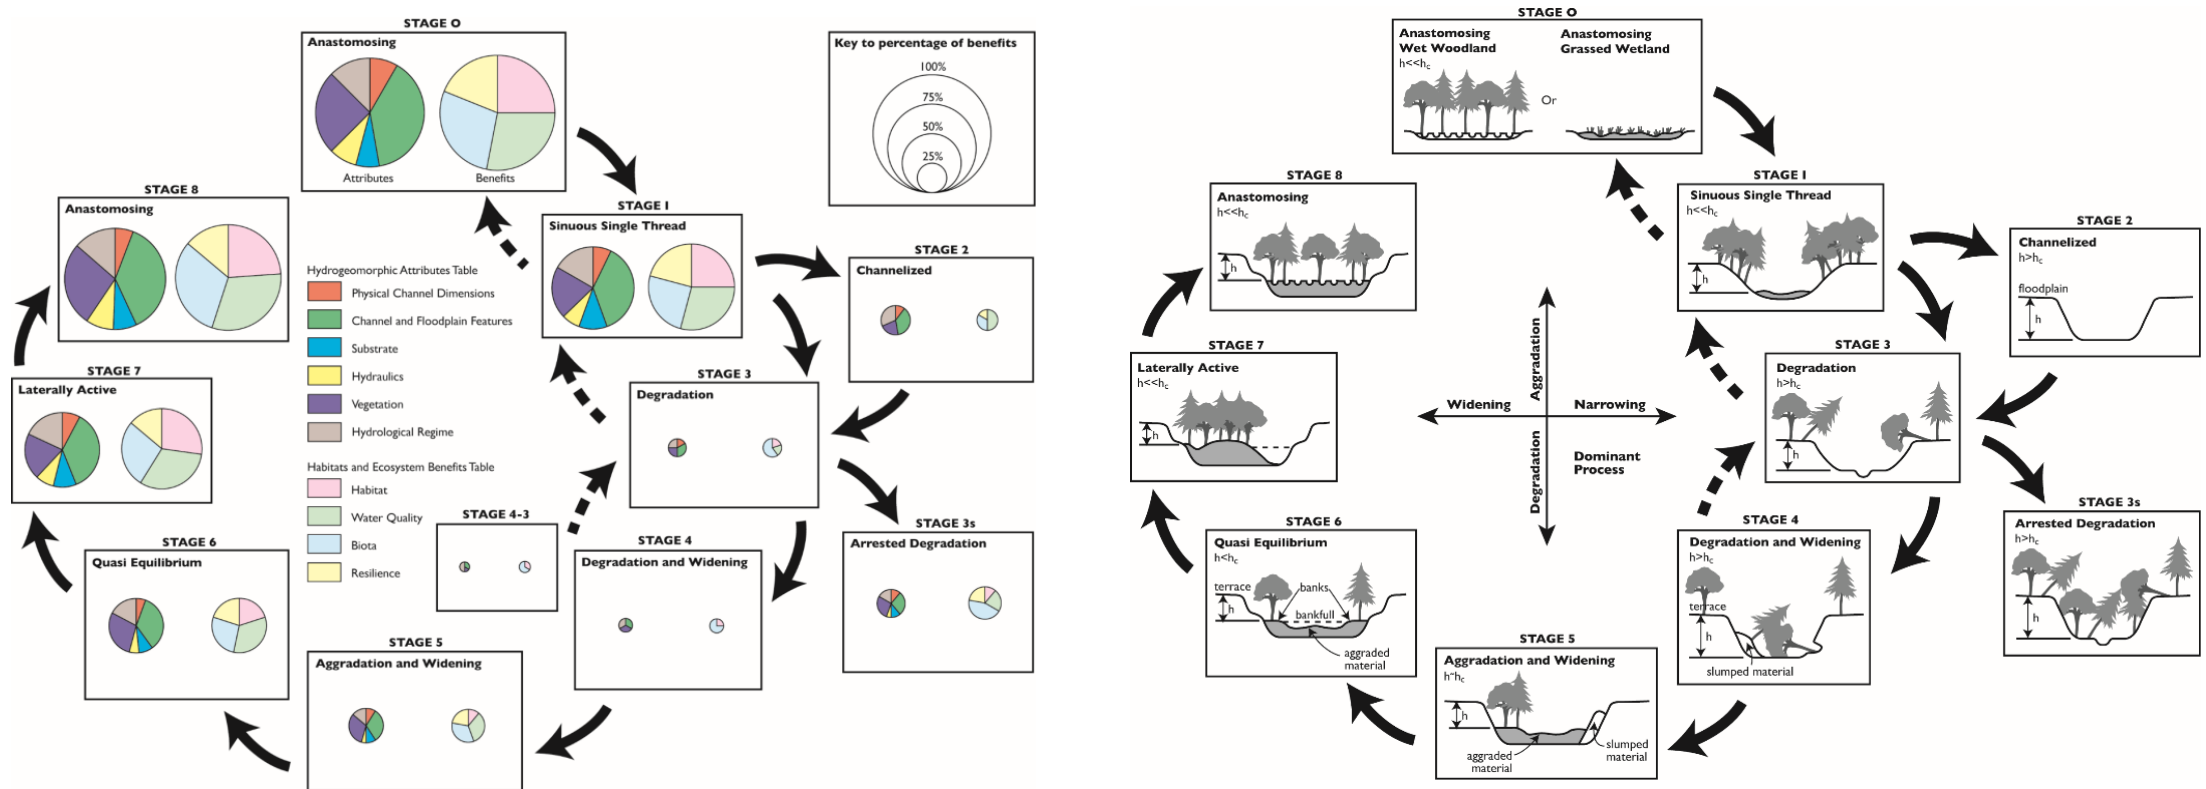
Cluer and Thorne (2013) argued that:

- high capacity 2yr Bank Full channels are not the historic norm,
- there are significant ecological differences between floodplain-connected (8/0/1) and incised stages (2/3/3a/4), as we make it around the different evolutionary stage's

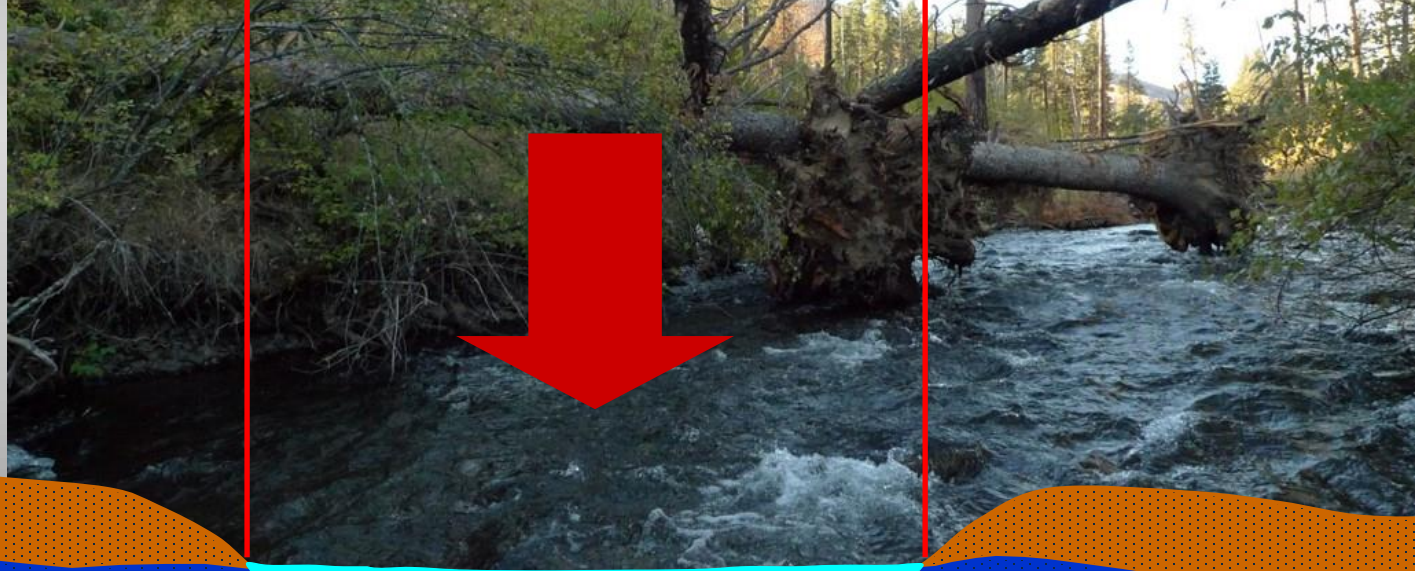
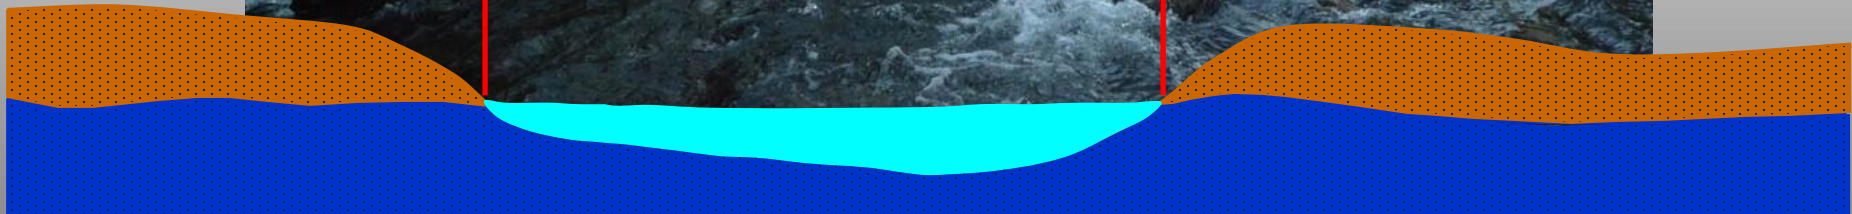
Frequency of over-bank flows reduced, larger water is routed from the flood plain and less channel conveys more flood flow, channel water is stored over time, riparian plants becomes unstable

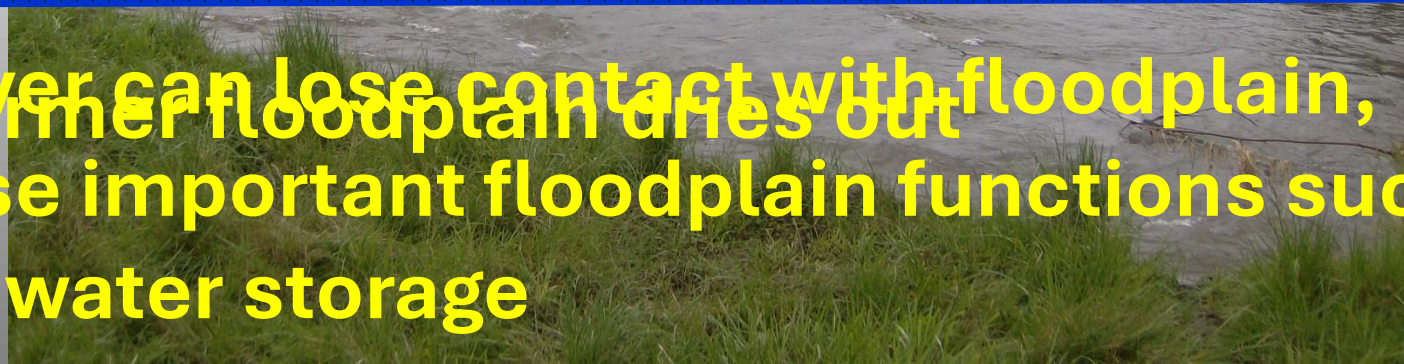
River can lose contact with floodplain, former floodplain dries out
lose important floodplain functions such as water storage

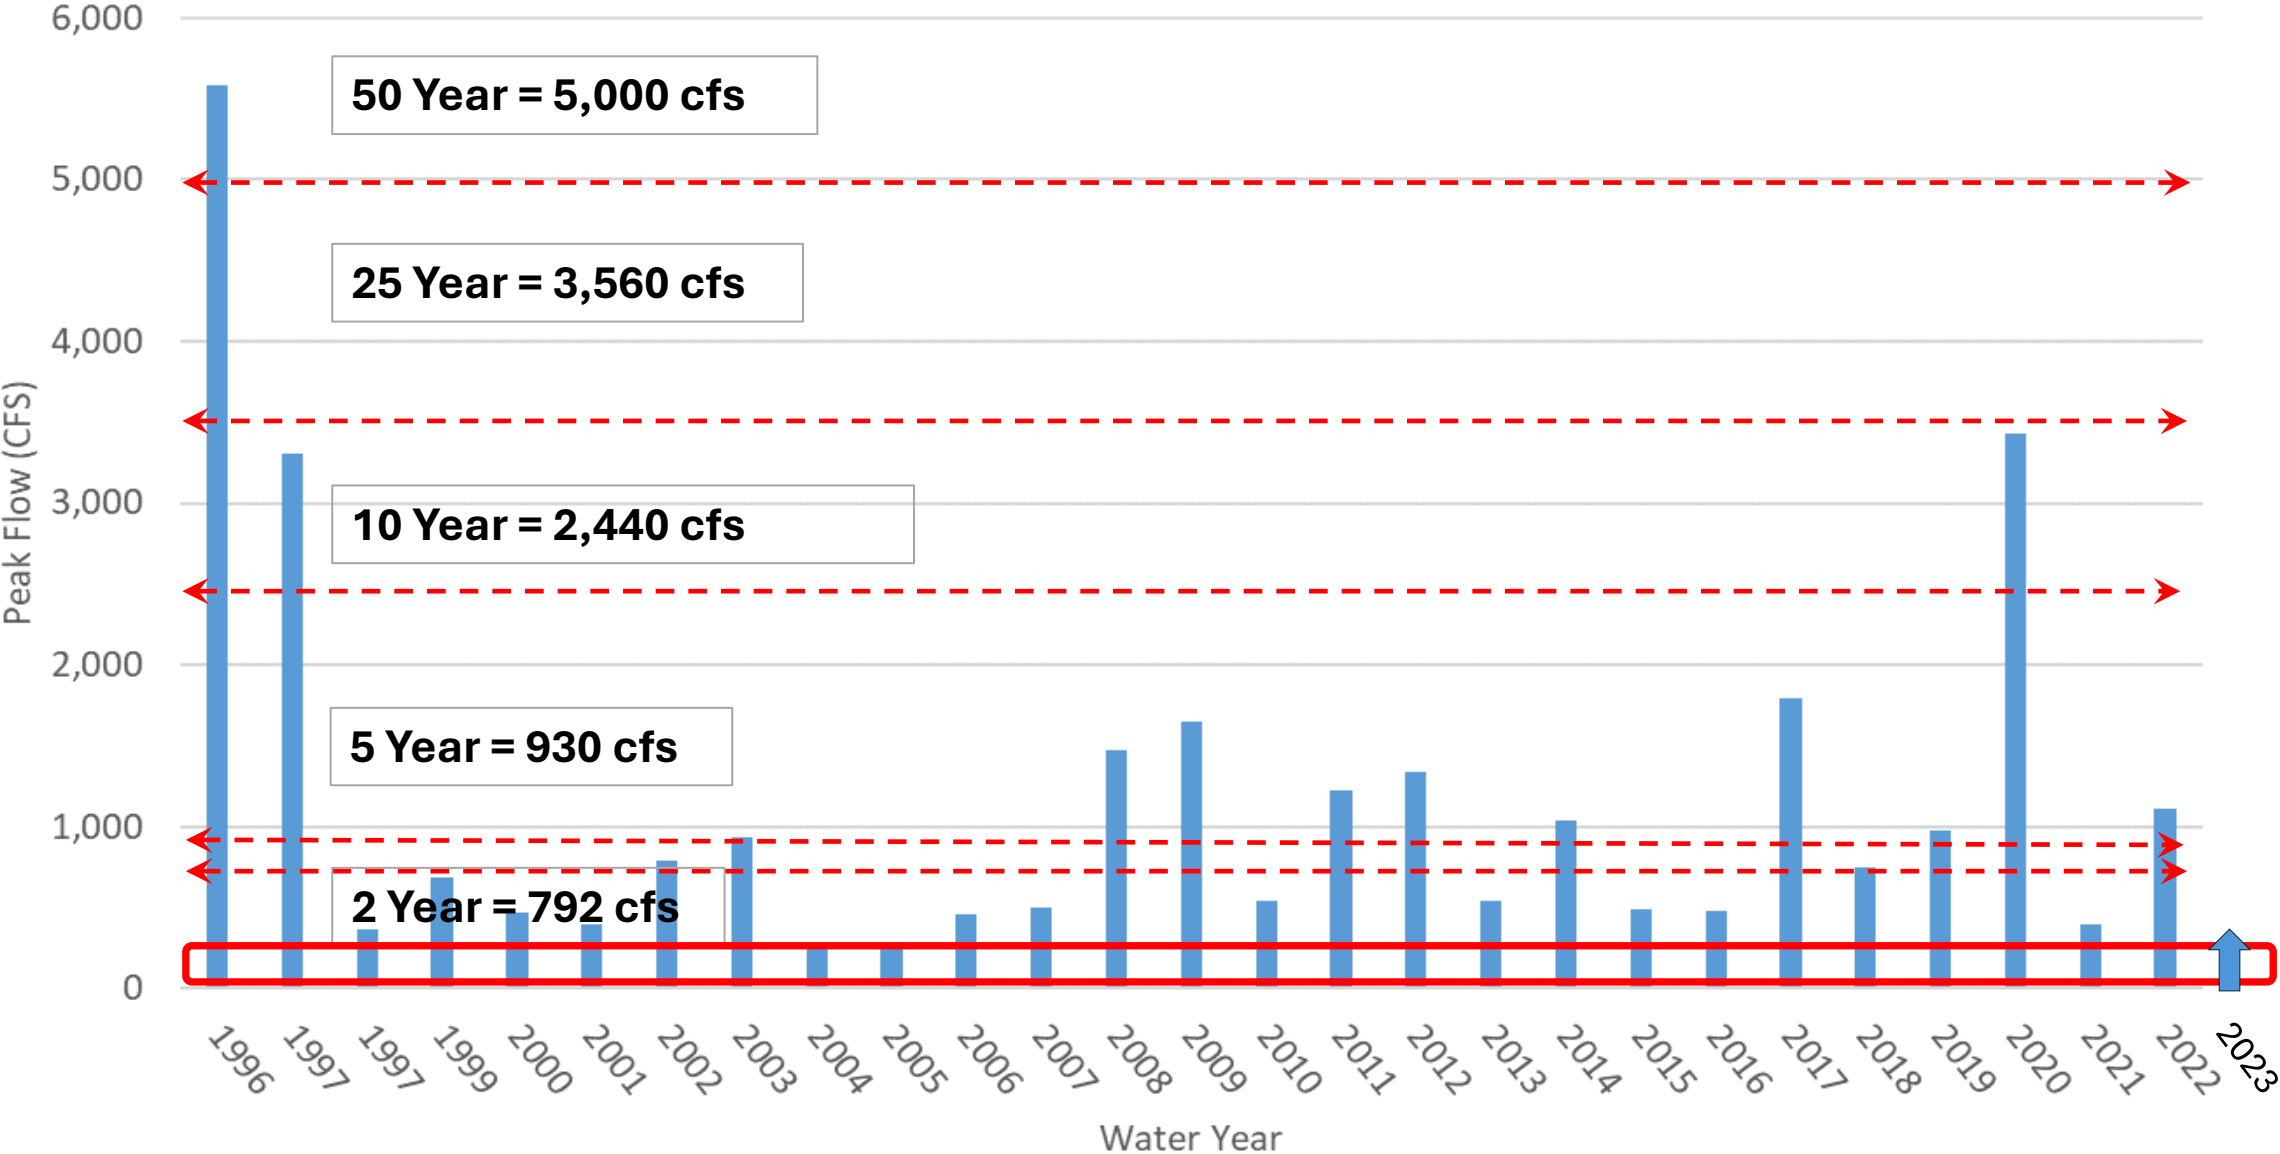
Geomorphic Timeline on the Tucannon River

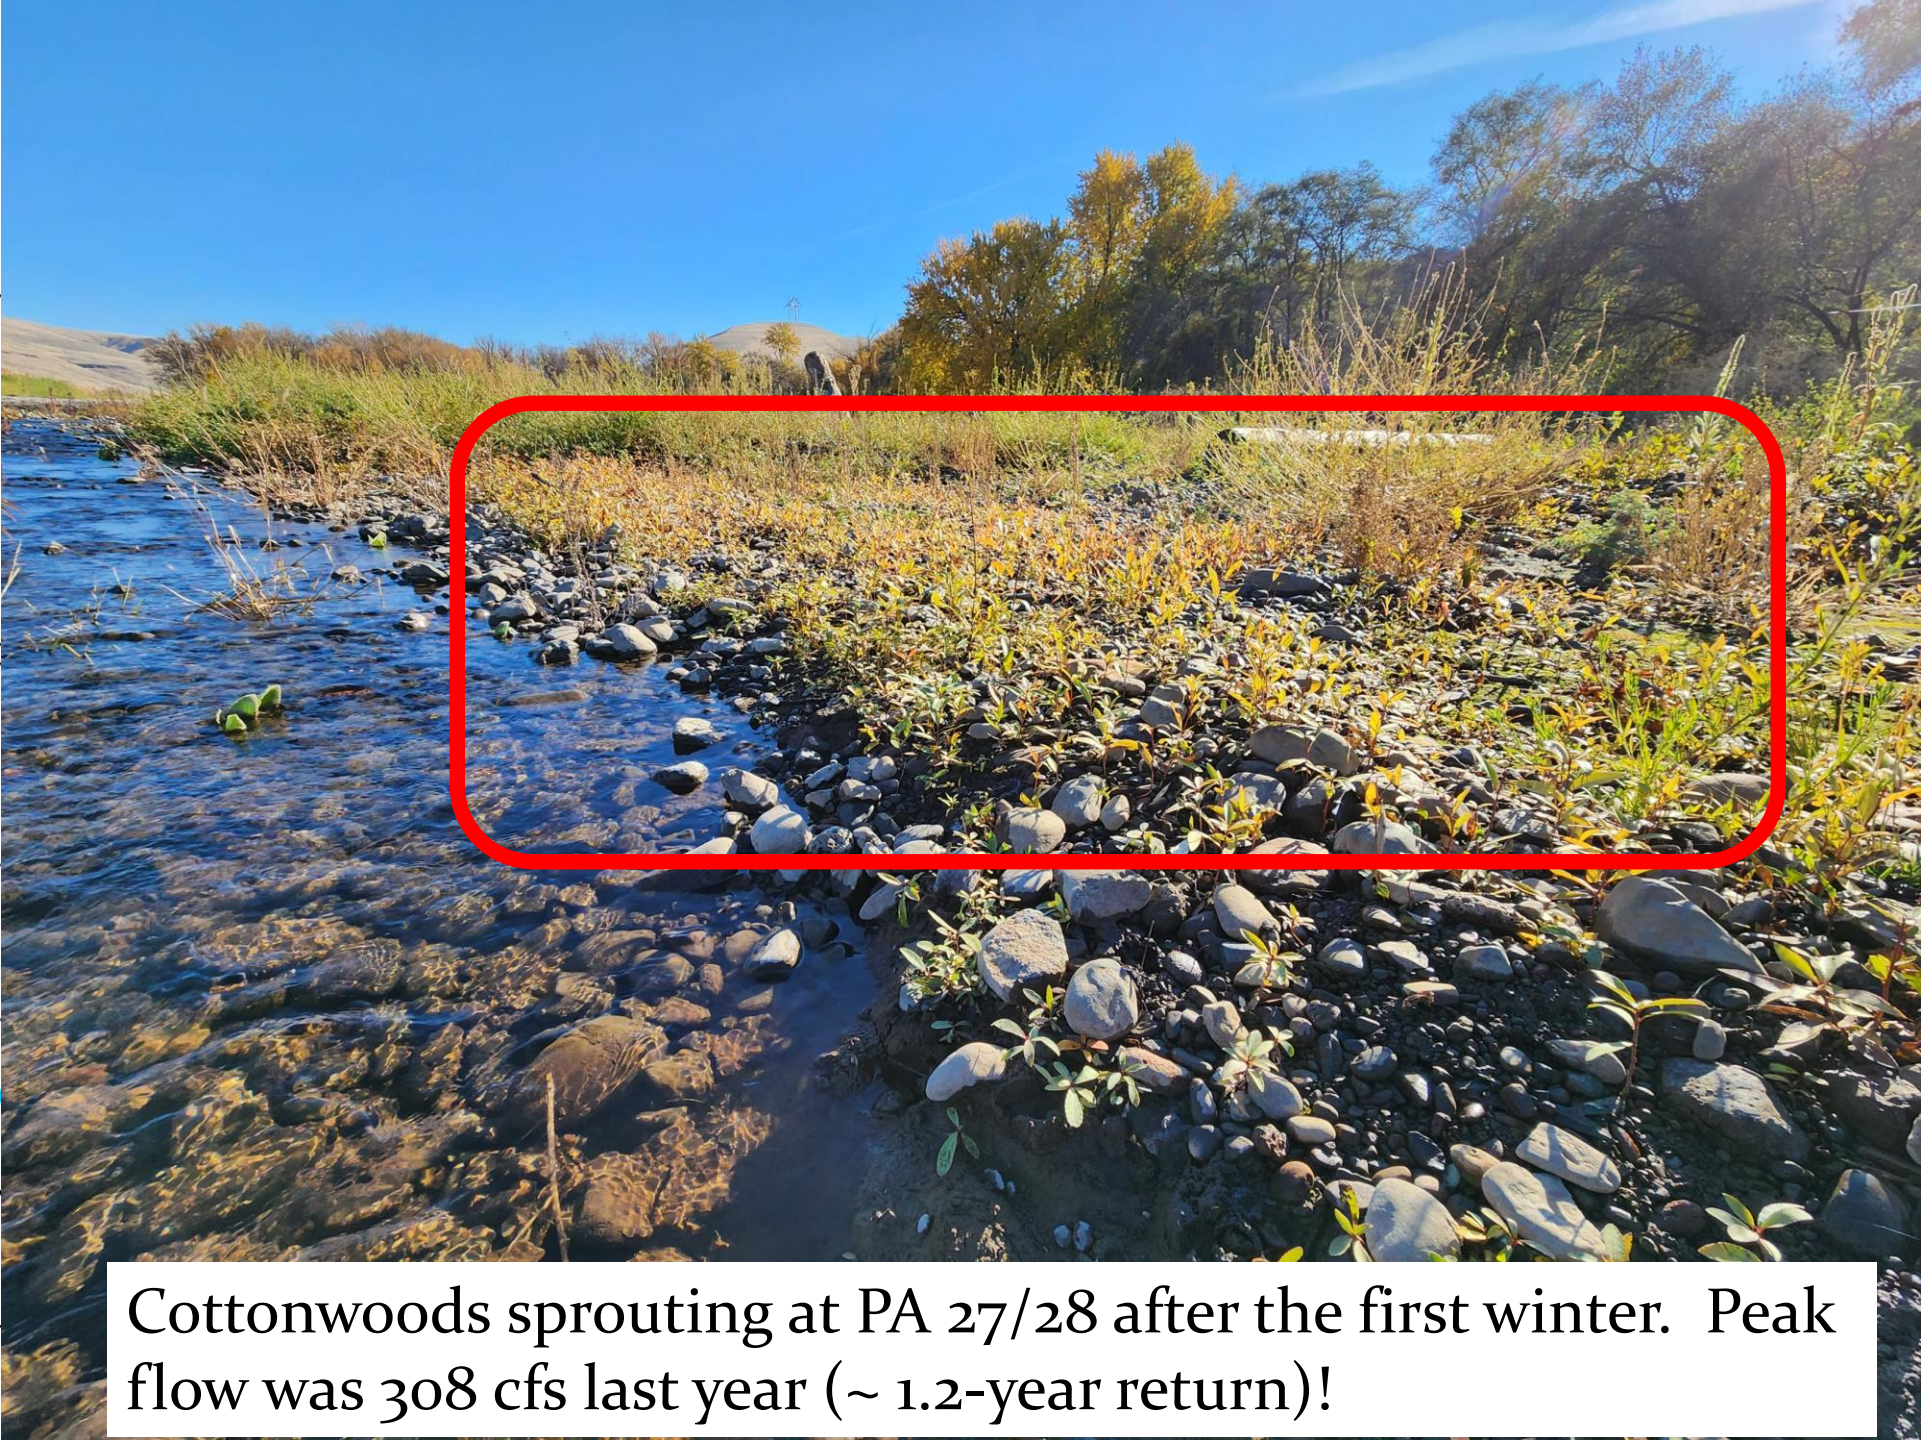
Cottonwoods sprouting at PA 27/28 after the first winter. Peak flow was 308 cfs last year (~ 1.2-year return)!

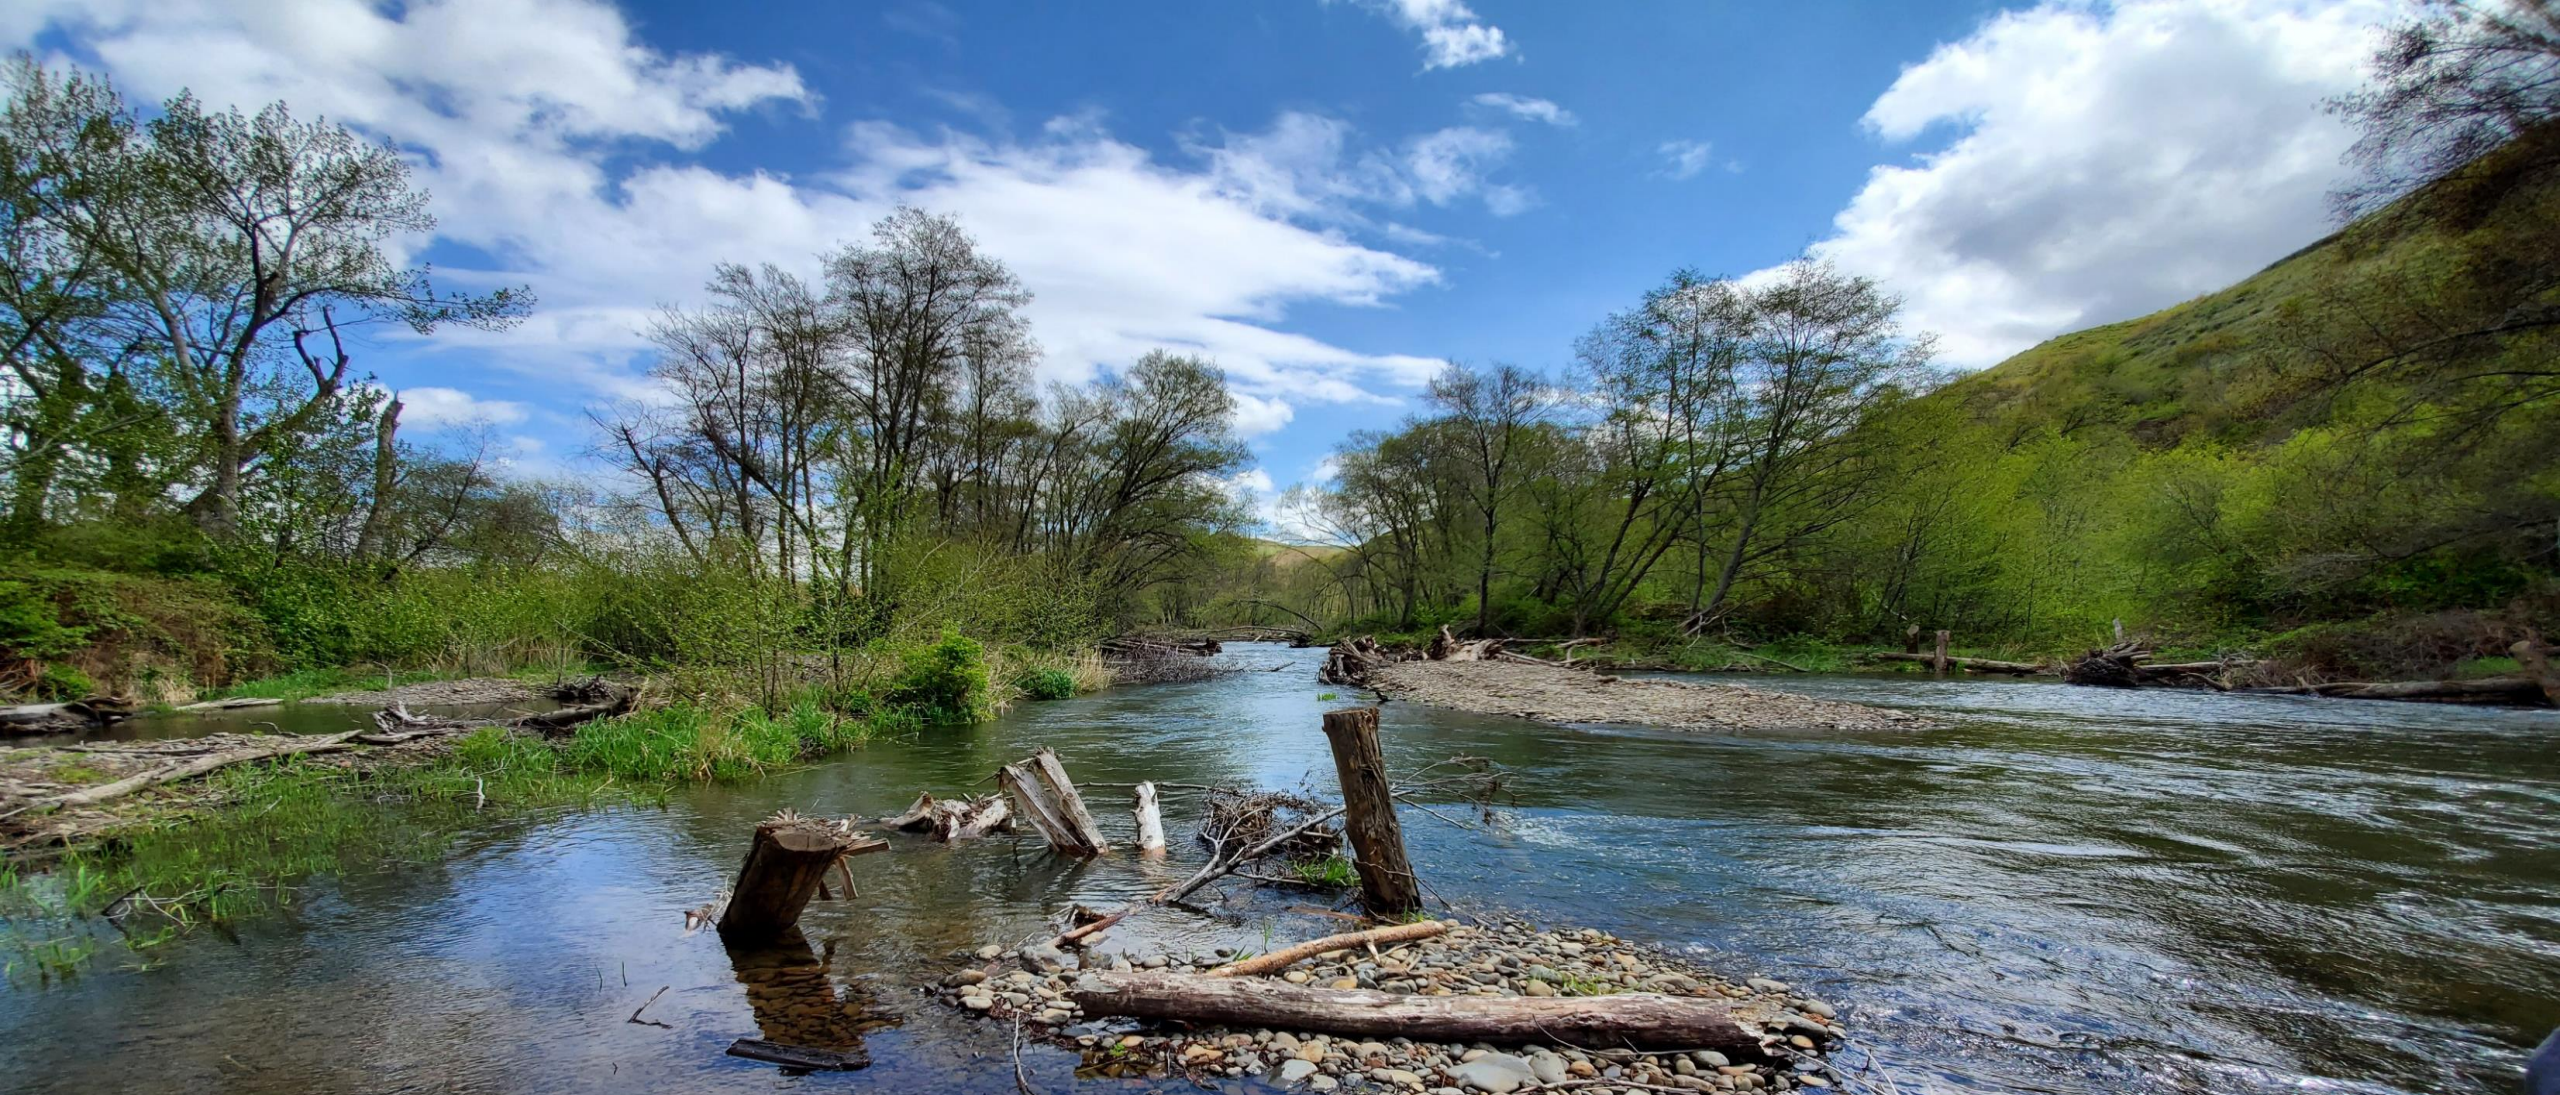
Floodplain connectivity on PA 27/28 completed in 2022
