George Davis Creek Fish Passage

A 1:12 scale physical model was used to develop and test performance of several LWM configurations, to restore and provide fish passage along a steep (7%) stream segment.

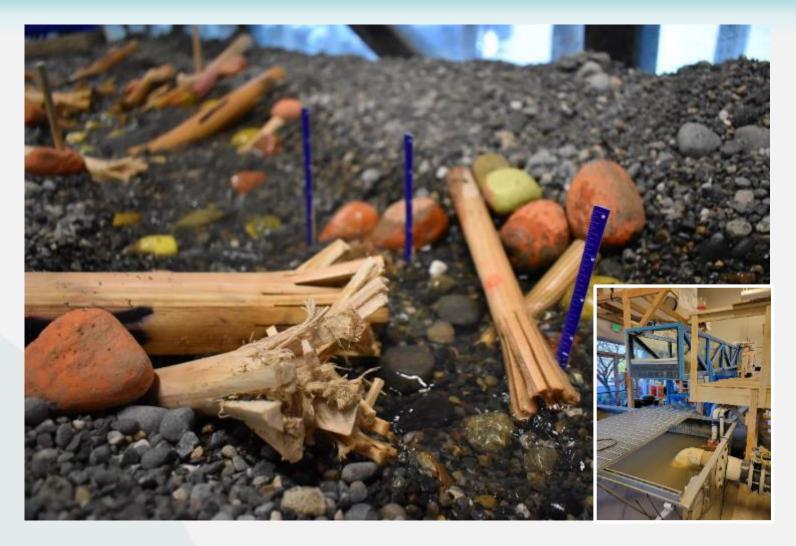
Prototype: George Davis Creek, Sammamish, WA

Tests include prototype-scaled sediment, LWM, and low to high (+100-yr) flows.

NHC Physical Model Laboratory, Tilting Bed Flume (inset), Seattle, WA

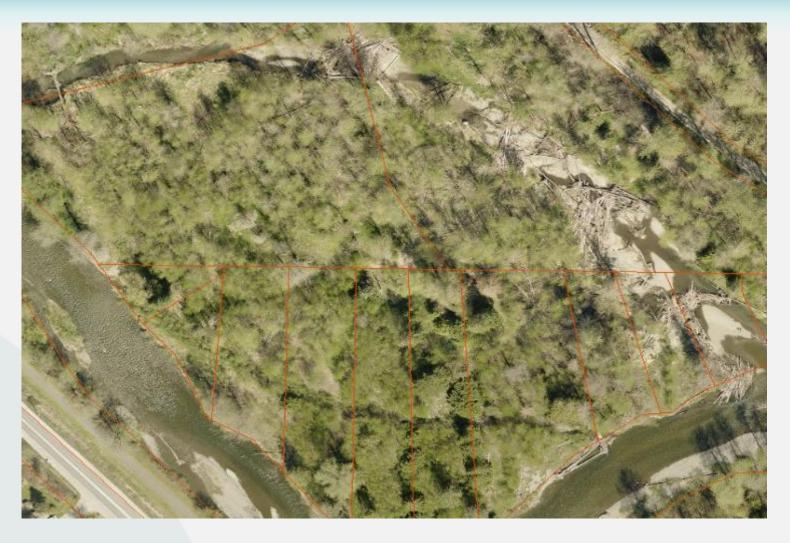
Cedar River (WRIA 8), Maple Valley, WA

Removal of obsolete levee and construction of pilot channels and LWD installation

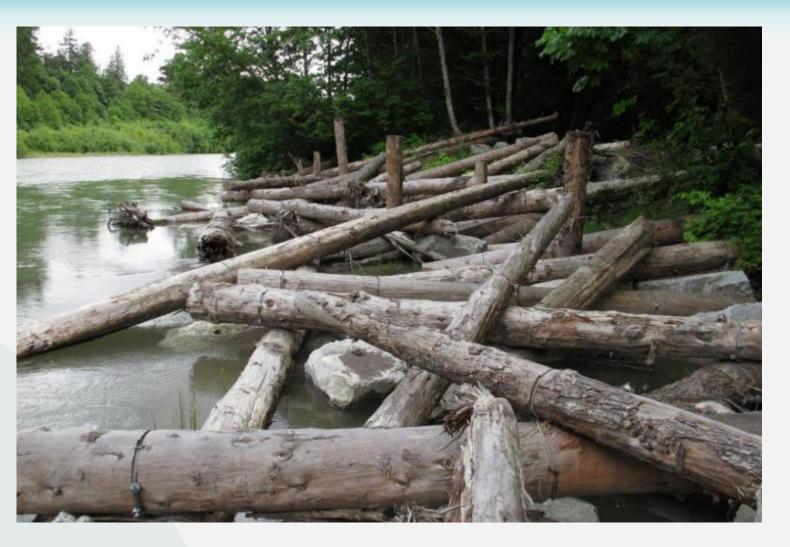
Cheakamus River, Squamish, BC

Pile-supported ELJ constructed adjacent to Squamish Nation IR 11 on the Cheakamus River to prevent erosion and lateral channel migration into Squamish Nation residences and provide valuable Steelhead and Chinook rearing habitat.

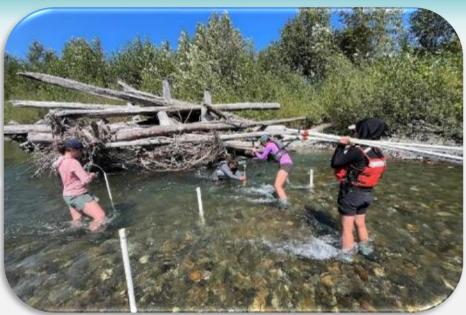
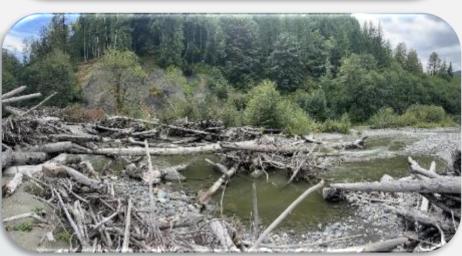
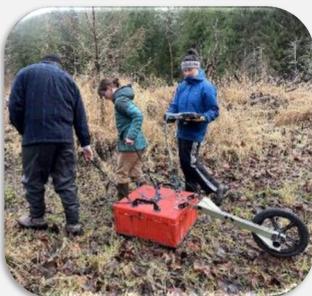
Project Location: South Fork Nooksack River - Acme, Washington

Assess the effectiveness of channel-spanning ELJs to increase floodplain connectivity and groundwater storage

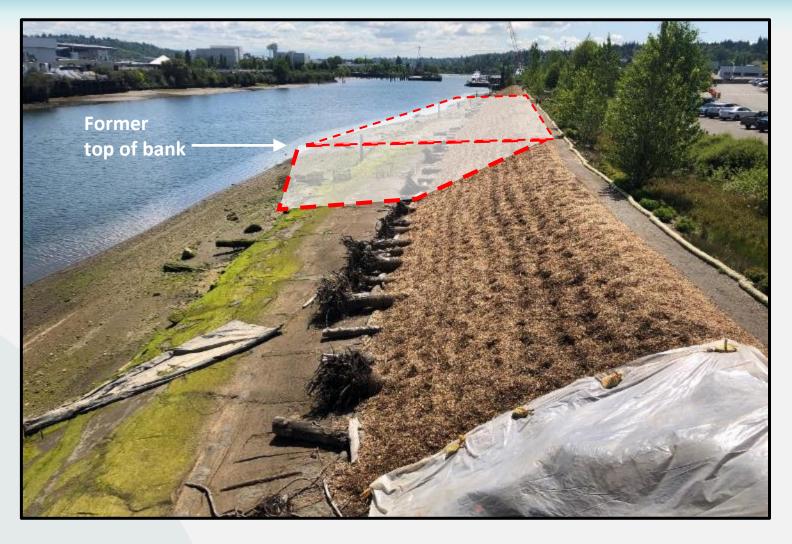
Lower Duwamish River; Green-Duwamish River Watershed; Seattle, Washington

- ~14 acres (5.6 ha) of estuarine marsh, intertidal mudflat, shoreline restoration, and public access.
- Over 800 pieces of LWM (at least 20 feet long, avg DBH 2 feet), totaling 1100 – 1225 tons of LWM onsite.
- Included toe, cross, edge, and riparian bench anchored logs, equaling ~4300 linear feet (1300 m).

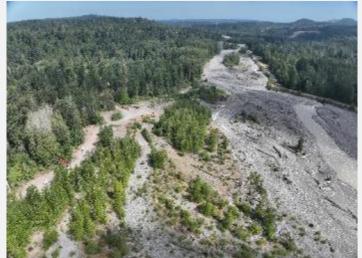
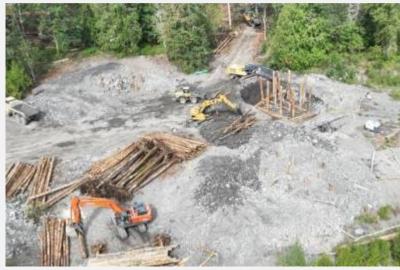
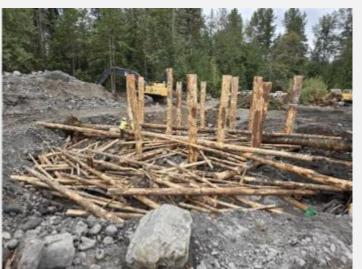
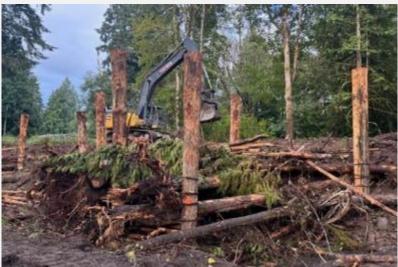
Upper Puyallup River Watershed
Orting, Washington State

Use of engineered log jams to encourage floodplain reconnection and side channel formation while also resisting channel migration towards primary lifeline arterial road.

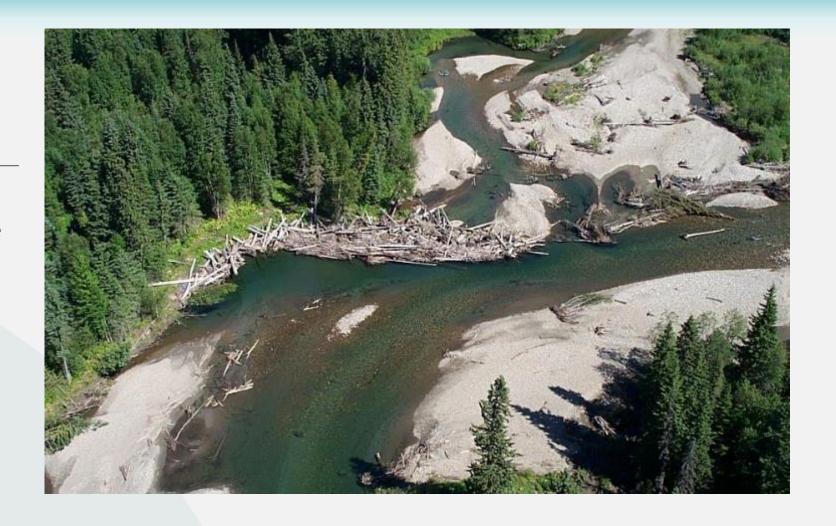
Pine River, Northeast BC

NHC designed and oversaw reconstruction of multiple ELJs on the Pine River that were removed due to an oil spill.

Reconstructed ELJs helped to stabilize the river, prevent channel avulsions, and mitigate loss of habitat using pilesupported frameworks with no ballast.

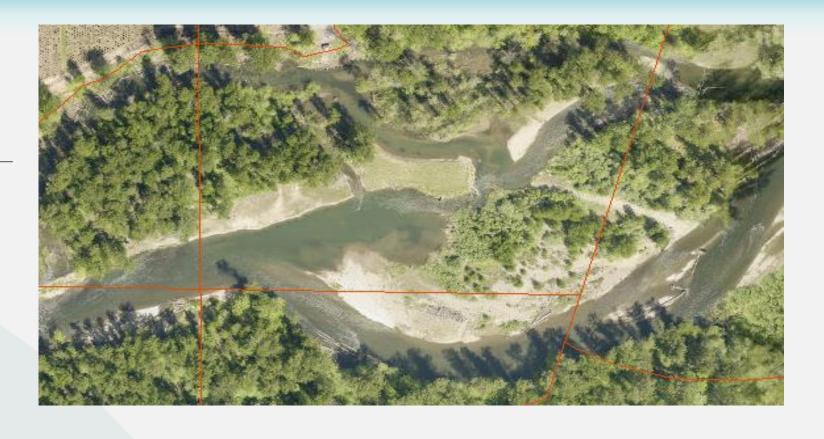
Green River (WRIA 9), Auburn, WA

Removal of levee and construction of setback revetment, pilot channels and LWD, reconnection to oxbow

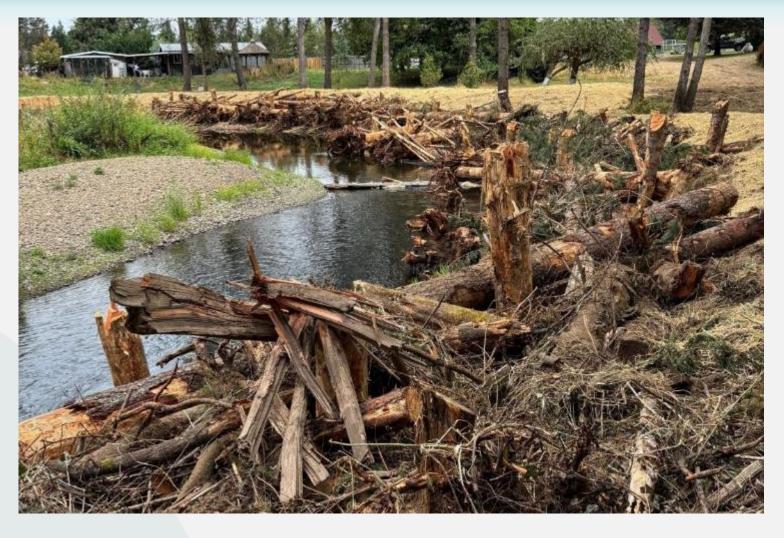
South Fork Newaukum River near Onalaska, WA.

Large wood installed to slow erosion and protect septic system. Project also enhanced instream habitat.

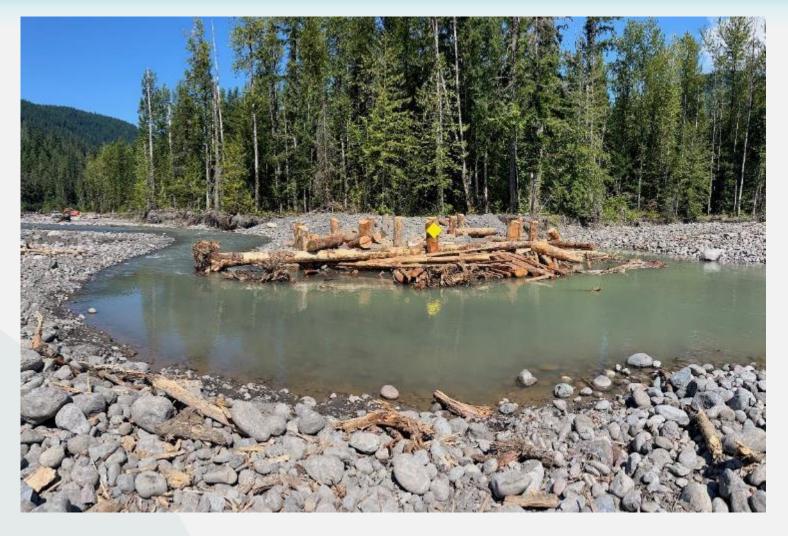
Middle Fork Nooksack River, Whatcom County, Washington

- 19 engineered log jams
- 9 flood fence post arrays to stabilize natural wood accumulations
- 1,300 feet of riparian plantings

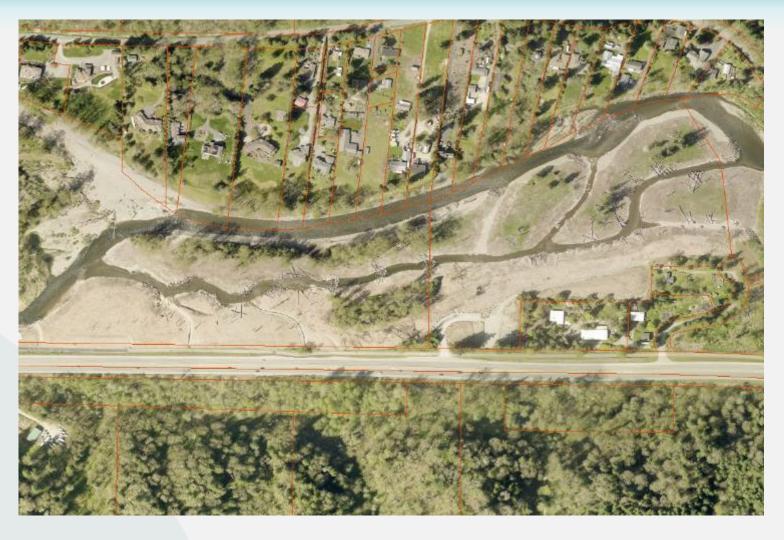
Cedar River (WRIA 8), Renton, WA

Removal of levee and construction of setback revetment, floodplain channels and LWD

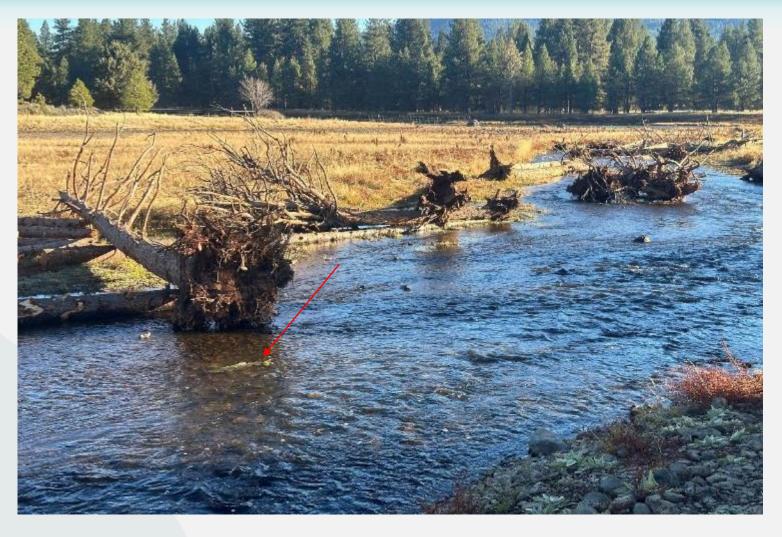
RES used helicopter placed wood in priority tributaries impacted by reservoir inundation to immediately provide cover for fish, improve channel fringe complexity, increase floodplain roughness, provide instream habitat, and to promote geomorphic change.

Spencer Creek, a tributary to the Klamath River in southern Oregon. Chinook salmon utilized the large woody material and spawned in this tributary in the first time in over 100-years.

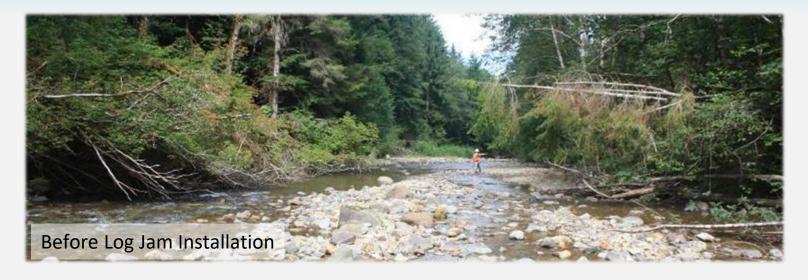
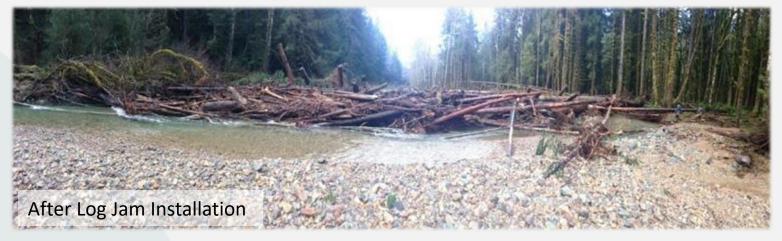
Clearwater River, tributary to the Upper White River in the Puyallup Watershed, 11 miles east of Enumclaw in Pierce County, Washington State

The project removed 1-mile of forest road and installed 28-log structures along 1.5 miles of river, including four 120' wide channel spanning structures pictured here. The intent of the project was to increase floodplain connectivity, reduce instream velocities, activate side channel and off-channel habitat, provide pools with overhead cover, and meter sediment to reduce mean substrate size for salmon spawning gravels.

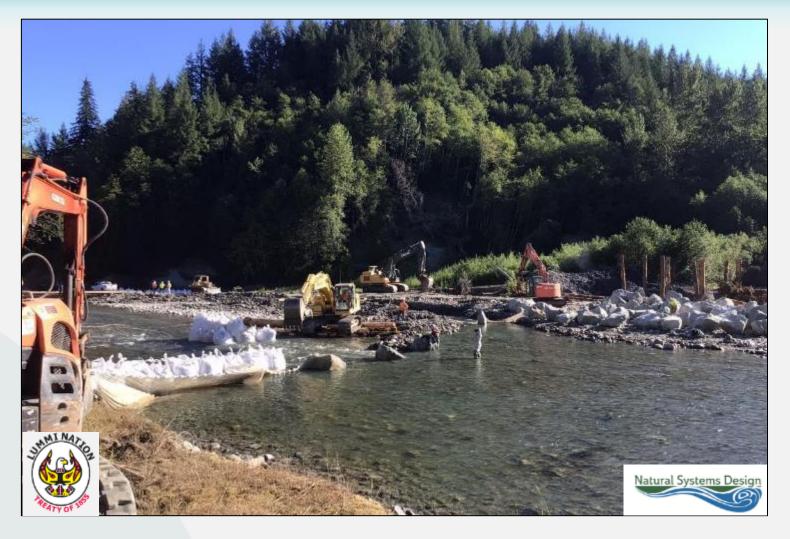
South Fork Nooksack River Watershed, Skagit County, Washington State

- 39 log jams constructed in 2022 and 2023, restoring 1.1 miles of mainstem.
- Improve holding and rearing habitat by constructing log jams to form deep, complex pools.
- Combat channel incision and engage the floodplain through the installation of low-lying channel spanning log jams.

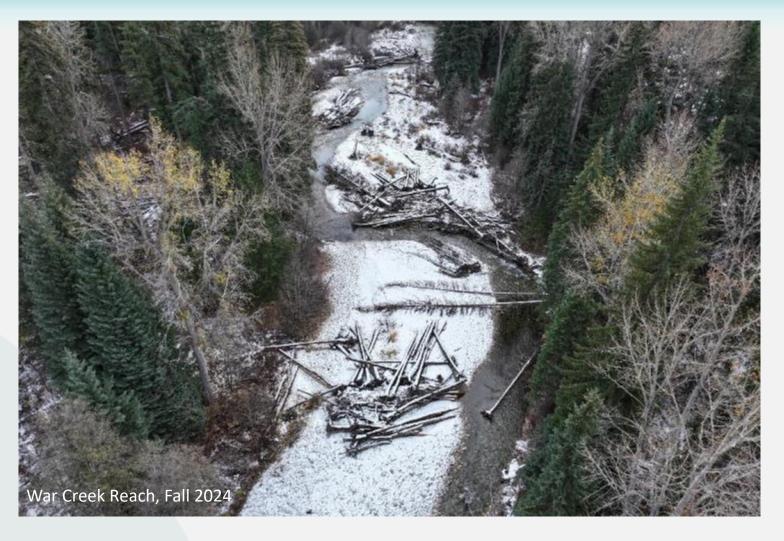
Twisp River, Methow Subbasin

- Installed 1100 pieces of large wood with rootwads.
- Installed 40 bundles of heavy slash.
- Constructed nearly 80 large wood structures
- Treated ~3.5 miles of high priority spawning and rearing habitat for endangered spring Chinook salmon, threatened Steelhead and Bull Trout.
- Constructed 8 piling ballasted, engineered log structures to retain flood mobilized material

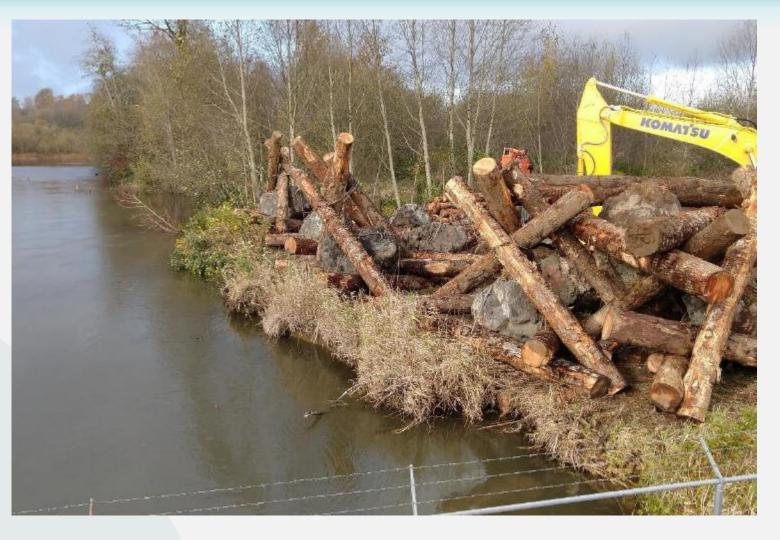
Wynoochee River, Washington State, USA

NHC evaluated and designed ballasted log jacks to be placed near a wastewater treatment plant to inhibit the Wynoochee River from avulsing around the treatment plant and to limit further scour and undermining of existing sheet pile infrastructure.

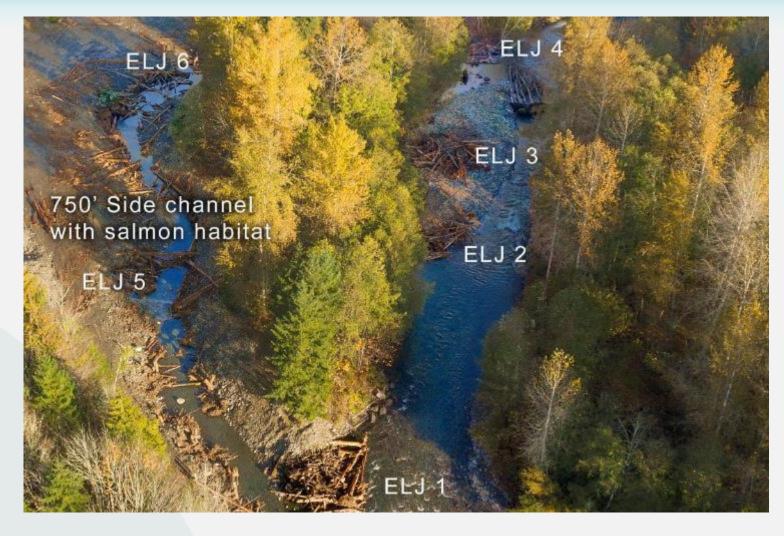
Dungeness River, Sequim, Washington State

Engineered Log Jams (ELJs) and Salmon Side Channel at Jamestown S'Klallam Tribe's Caldero Property.

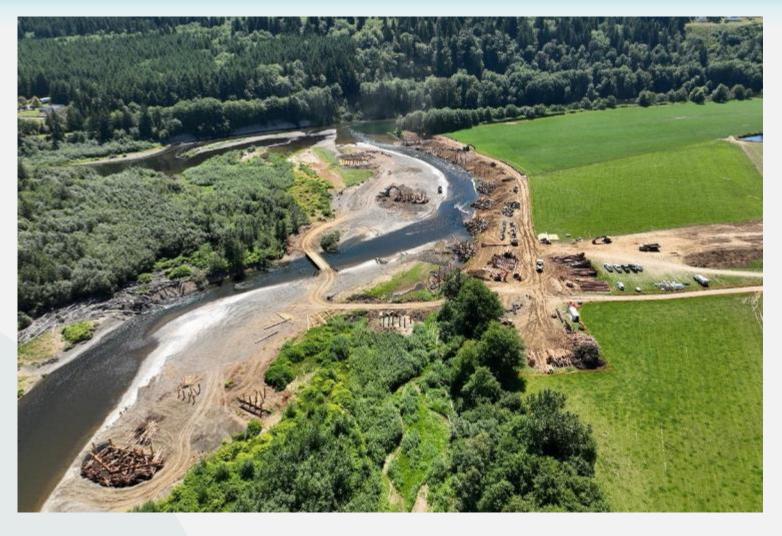
Montesano, Grays Harbor County, Washington State

Re-establish dynamic floodplain processes that support salmonids by installing engineered log jams and restoring 350 acres of riparian forest. Log jams installed to reduce erosion of >50 ft. per year, to create scour pools, provide cover, create/enhance side channels, and promote stability for regeneration of mature riparian forest.

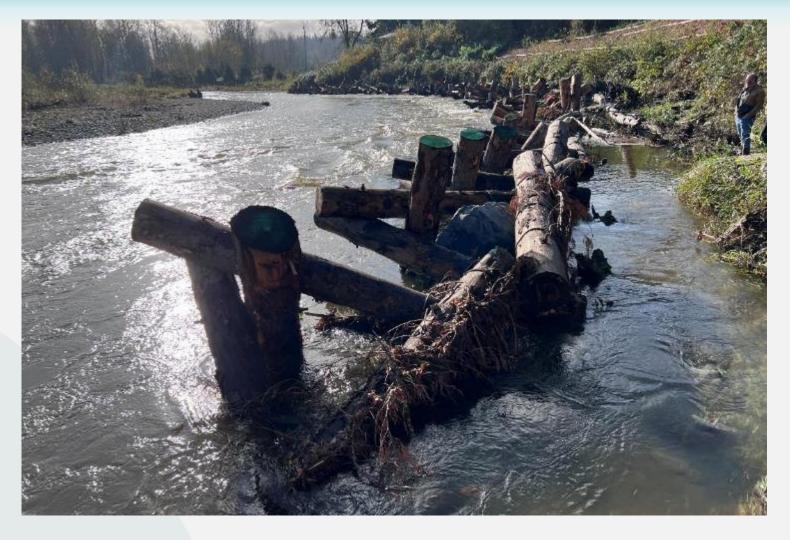
Pilchuck River near State Route 92, Snohomish County, WA

This project supplied stable complex habitat for aquatic organisms, with a secondary benefits of stabilizing the toe of a stream bank.

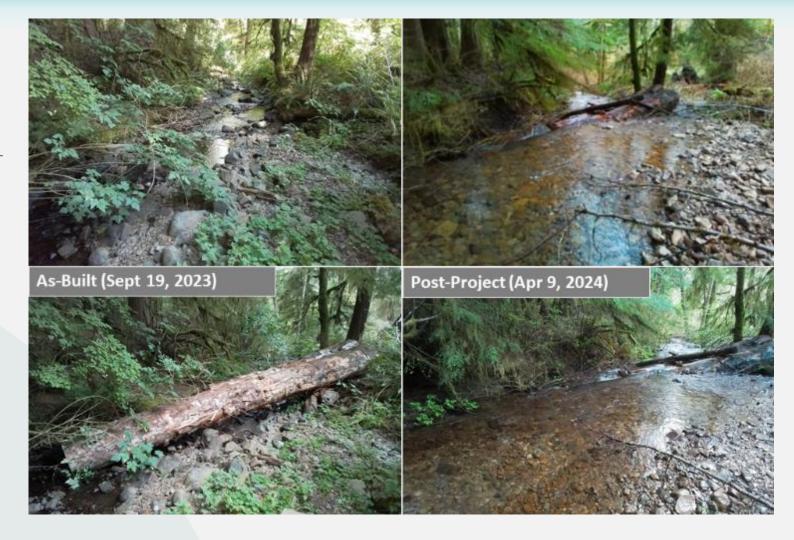
Andy Creek (Sand Lake Watershed, near Pacific City, Oregon)

LWD placement site in Andy Creek that accumulated several feet of spawning gravel in one winter after project implementation. A winter steelhead redd was observed during the first spring after implementation in an area previously devoid of spawning gravel (bottom right picture).

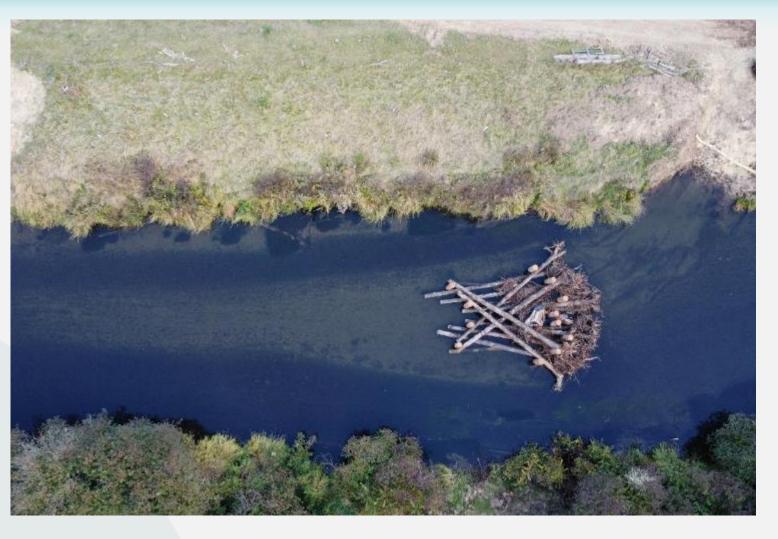
Near Bucoda, Washington (Chehalis River Basin)

The project increases in-channel large wood structure, promotes retention of gravel and wood, improves floodplain connectivity, increases the quantity and formation of side-channel and floodplain habitats, and restores and enhances riparian functions.

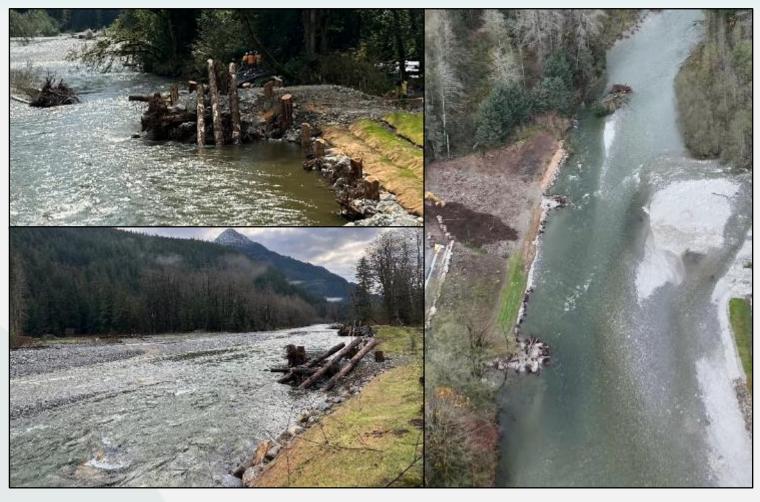
Indian River (x?əlílwəta?+) Watershed, Greater Vancouver Area, British Columbia

70 m of riverbank treated with engineered log jams, a root wad revetment, and brush layering. Total of 51 fir/cedar logs & 30 root wads used in construction.

Why: Restore the riverbank following new pipeline construction & mitigate progressive bank erosion threatening existing buried pipeline infrastructure.

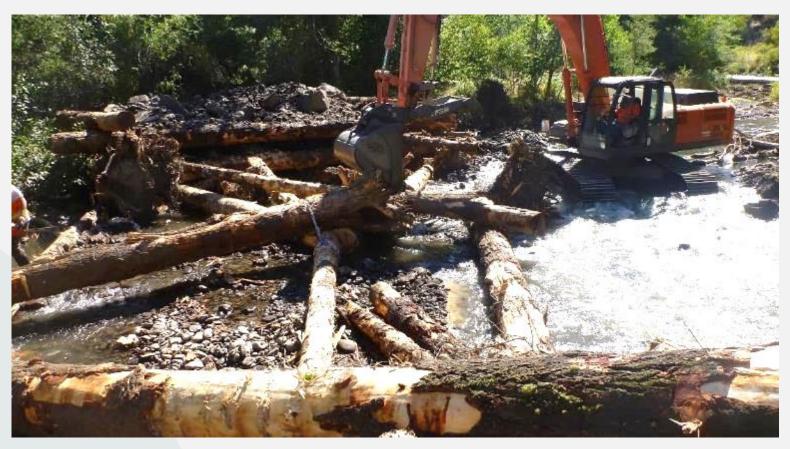
Near Dayton, Washington (Snake River Basin)

Multi-mile habitat restoration project to increase wood loading, provide instream structure, side channel, and floodplain connectivity with engineered log jams and floodplain channel excavations. Photo of main channel spanning log jam to create flow split being installed.

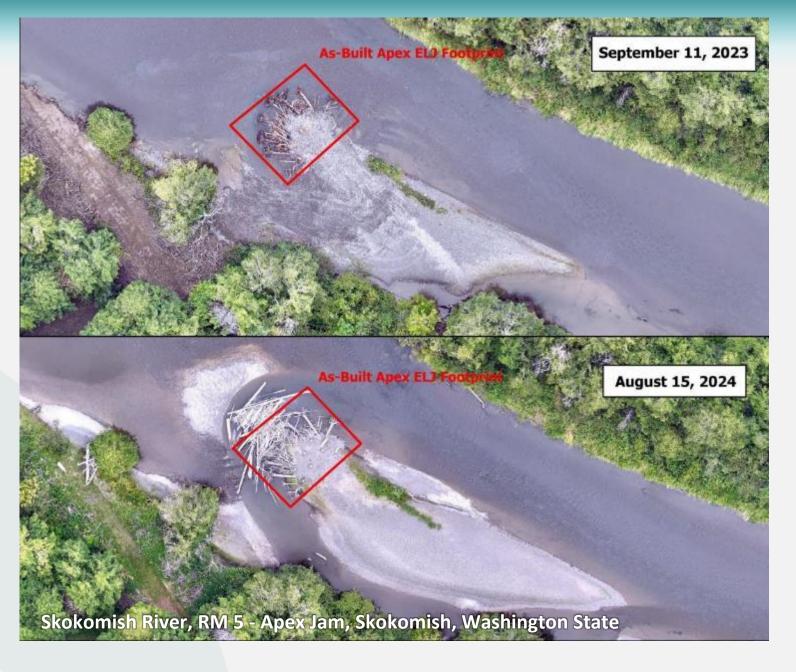
The Skokomish Indian Tribe – Natural Resources Department in collaboration with the Mason Conservation District installed 8 engineered log jams, including one large apex jam and 7 smaller deflector log jams placed along the south bank downstream of the apex jam. In addition, a 2,000-foot-long side channel was excavated.

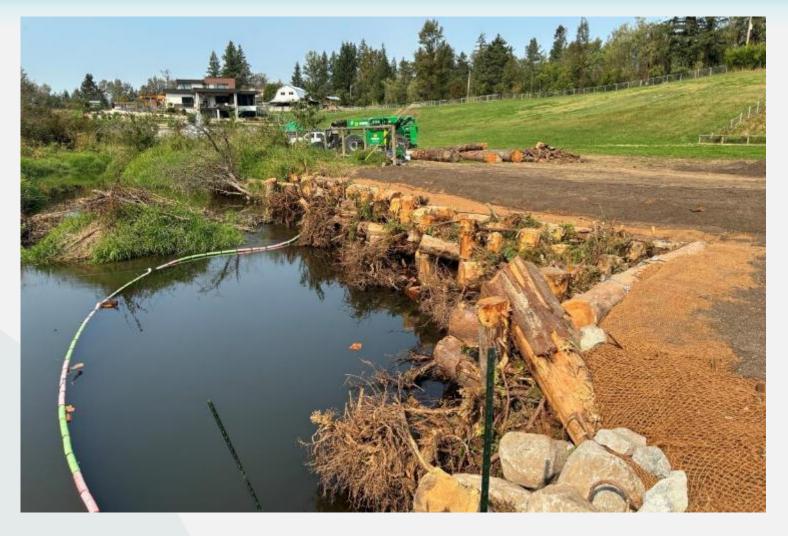
Salmon River, Langley BC

Rapid bank recession due to toe erosion of silty-sand substrate, minimal riparian vegetation and increasingly flashy system.

Bank stabilization using an interlocking matrix of large wood, driven piles, brush, and ballast rock. Soil wraps placed to buttress remaining vertical bank and restore riparian area.

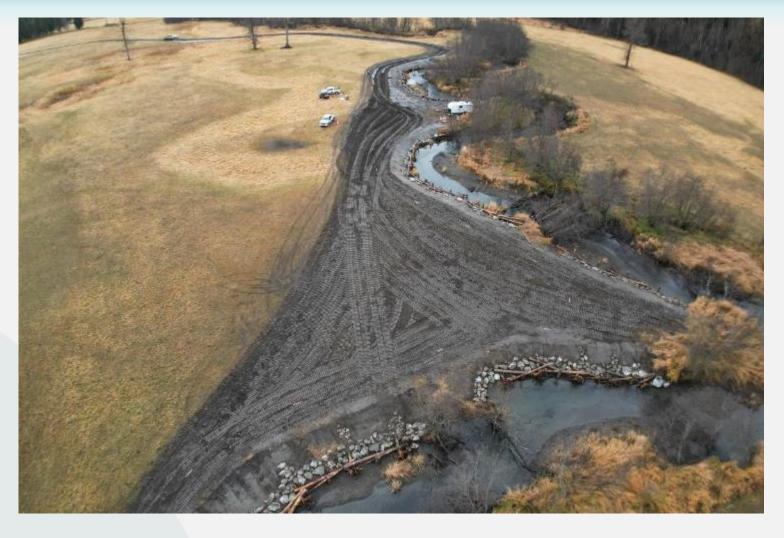
Louis Creek, northeast of Kamloops BC

The objective of the project was to stabilize the banks of six stream bends along Louis Creek with woody debris, to allow for the re-establishment of the riparian area, while enhancing fish habitat.

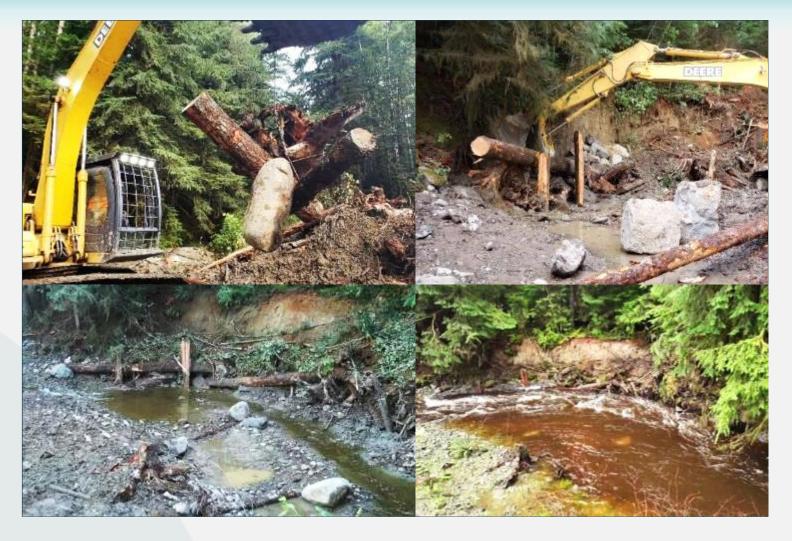
Iron River FSR 1.7km, Campbell River, British Columbia

Rootwad & boulder revetments to slow bank erosion and improve fish passage

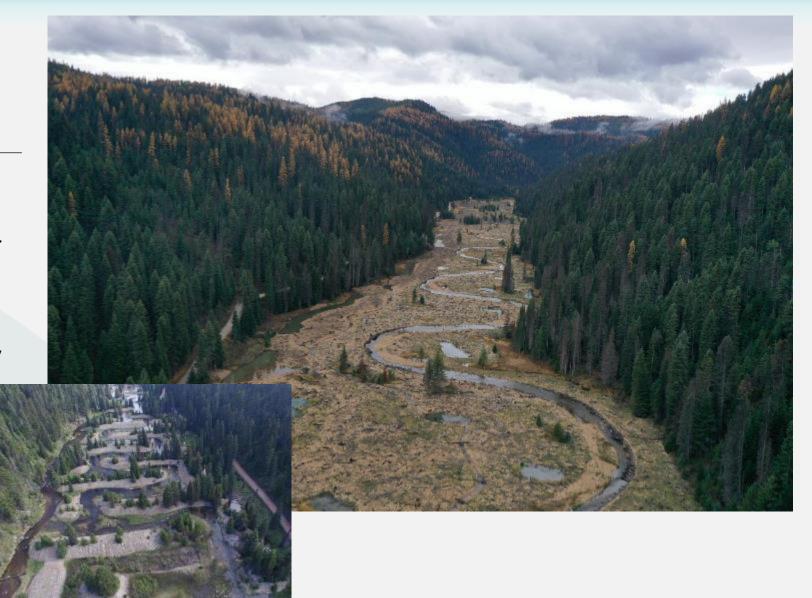
Large-scale river and floodplain restoration of historic dredge mining in the Upper South Fork Clearwater River

77 acres of graded floodplain

3 miles of reconstructed river channel

62+ large wood structures

4,000 feet of large wood as bank stability

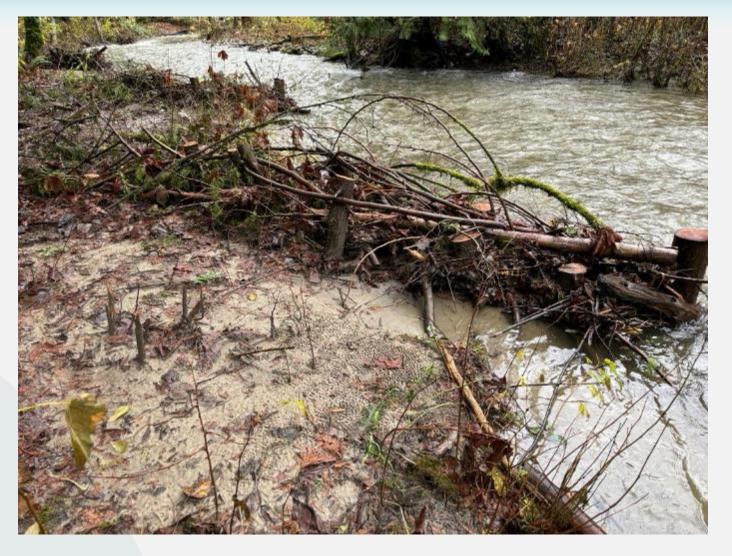
Clayburn Creek, Abbotsford BC

Relatively uniform reach within urbanizing stream with very shallow flows.

A series of post-assisted log structures (PALS) were installed along the left bank to emulate nature LWD deposition patterns. Structures designed to retain natural floating wood after installation. PALS create localized scour and provide dense overhead cover adding habitat complexity.
