DFO / PSF Knowledge Exchange

**Large Wood Applications in
River Restoration**

Case Study – Indian River

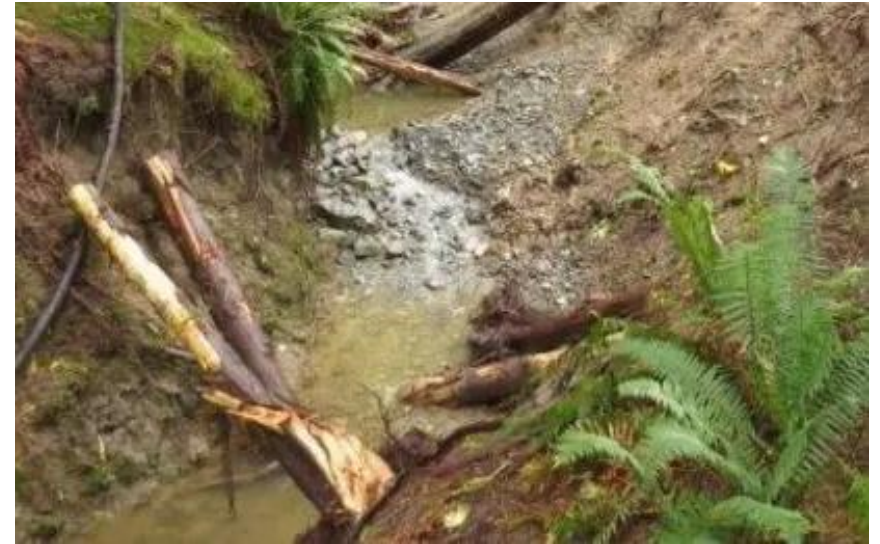
LWD is predominantly viewed as a “structure” for direct fish utilization rather than an influencer of morphology (productivity, stability etc)

**Singular pieces
Sub-optimal orientation
Conservative placements
Limited to no effects on scour
Limited to no recruitment of fluvial debris***

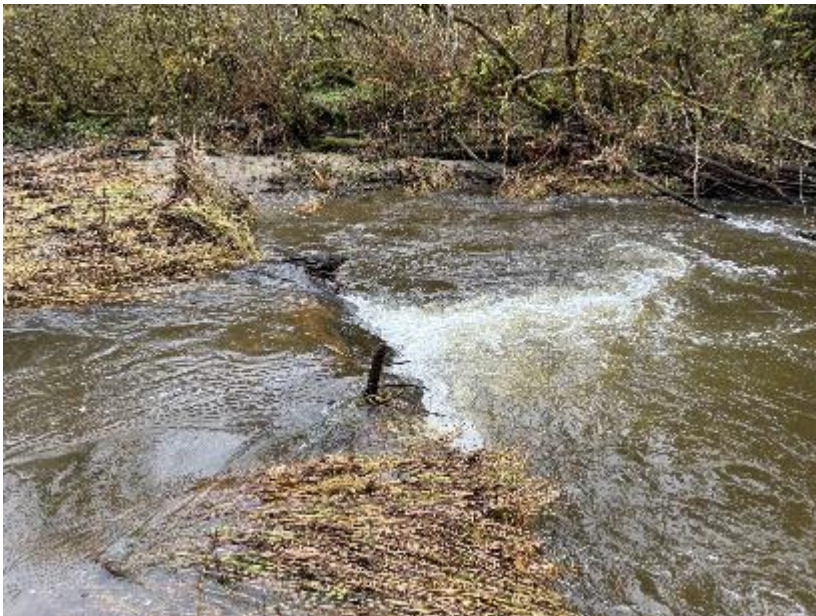
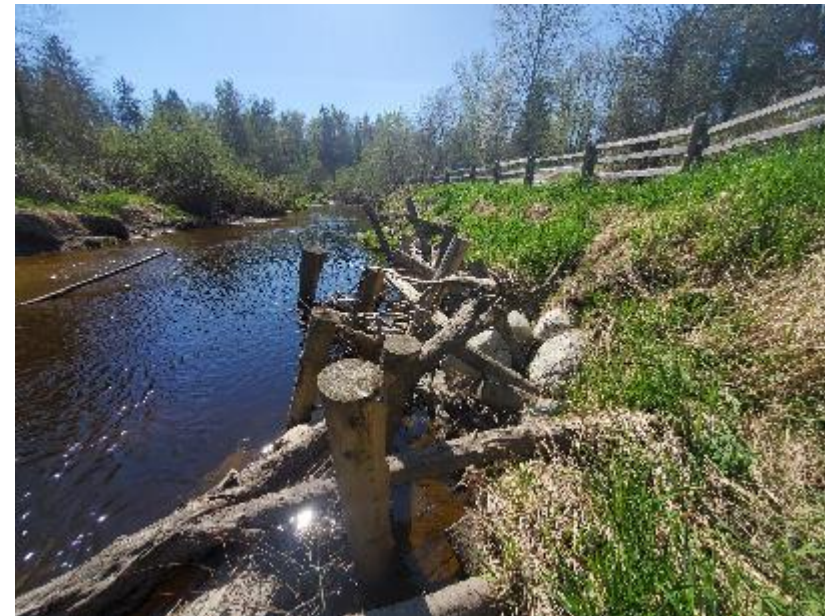
Vs LWD as Influencer:

Scour – *depth and heterogeneity of channel*

Substrate sorting – *benthic productivity and spawning*

Grade control- *better habitat*

Bank stability- *increasing stability, protecting riparian*

Bar accretion - *vegetation colonization*

Side channel dynamics – *buffered habitat*

Nutrient retention - *productivity*

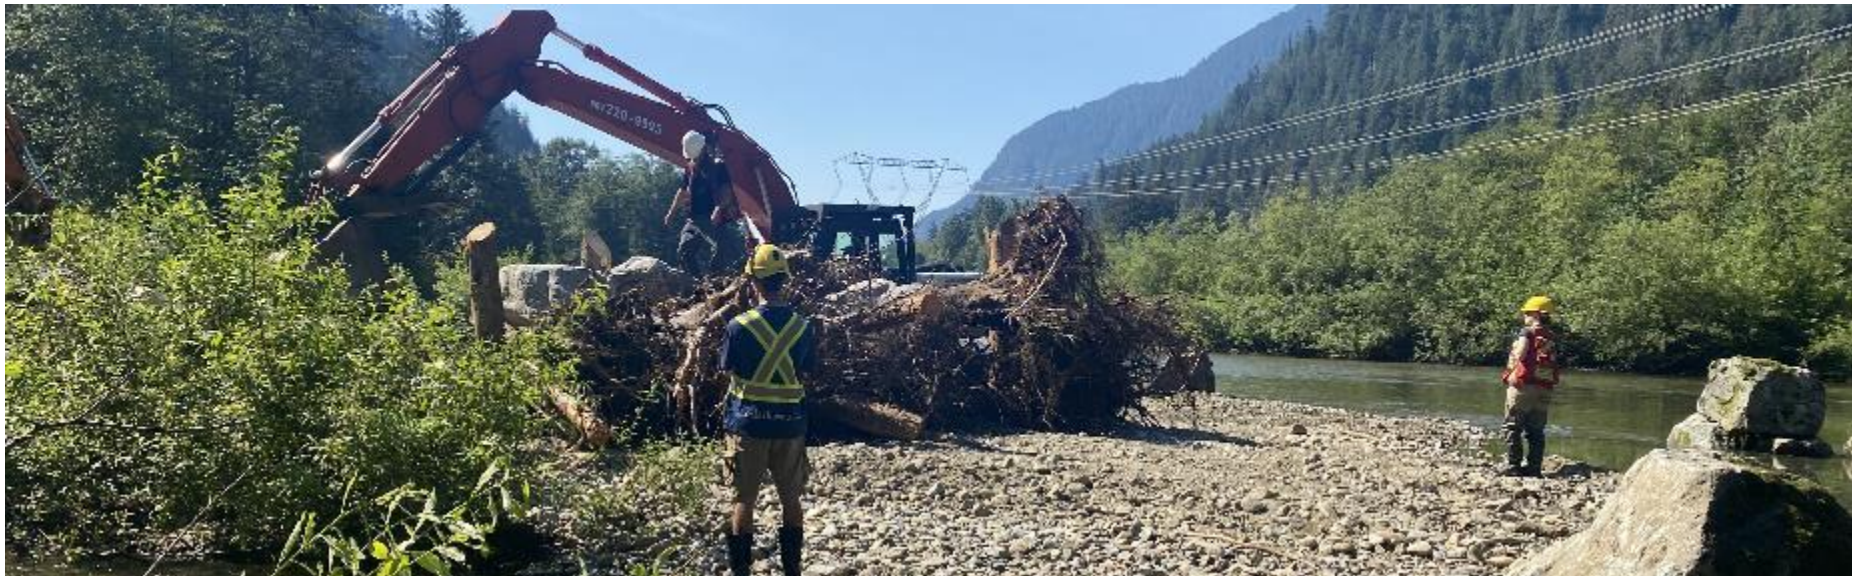
Plan: “Nudge” the channel east to improve flow split using a spur, bar-head jam and one-time gravel removal

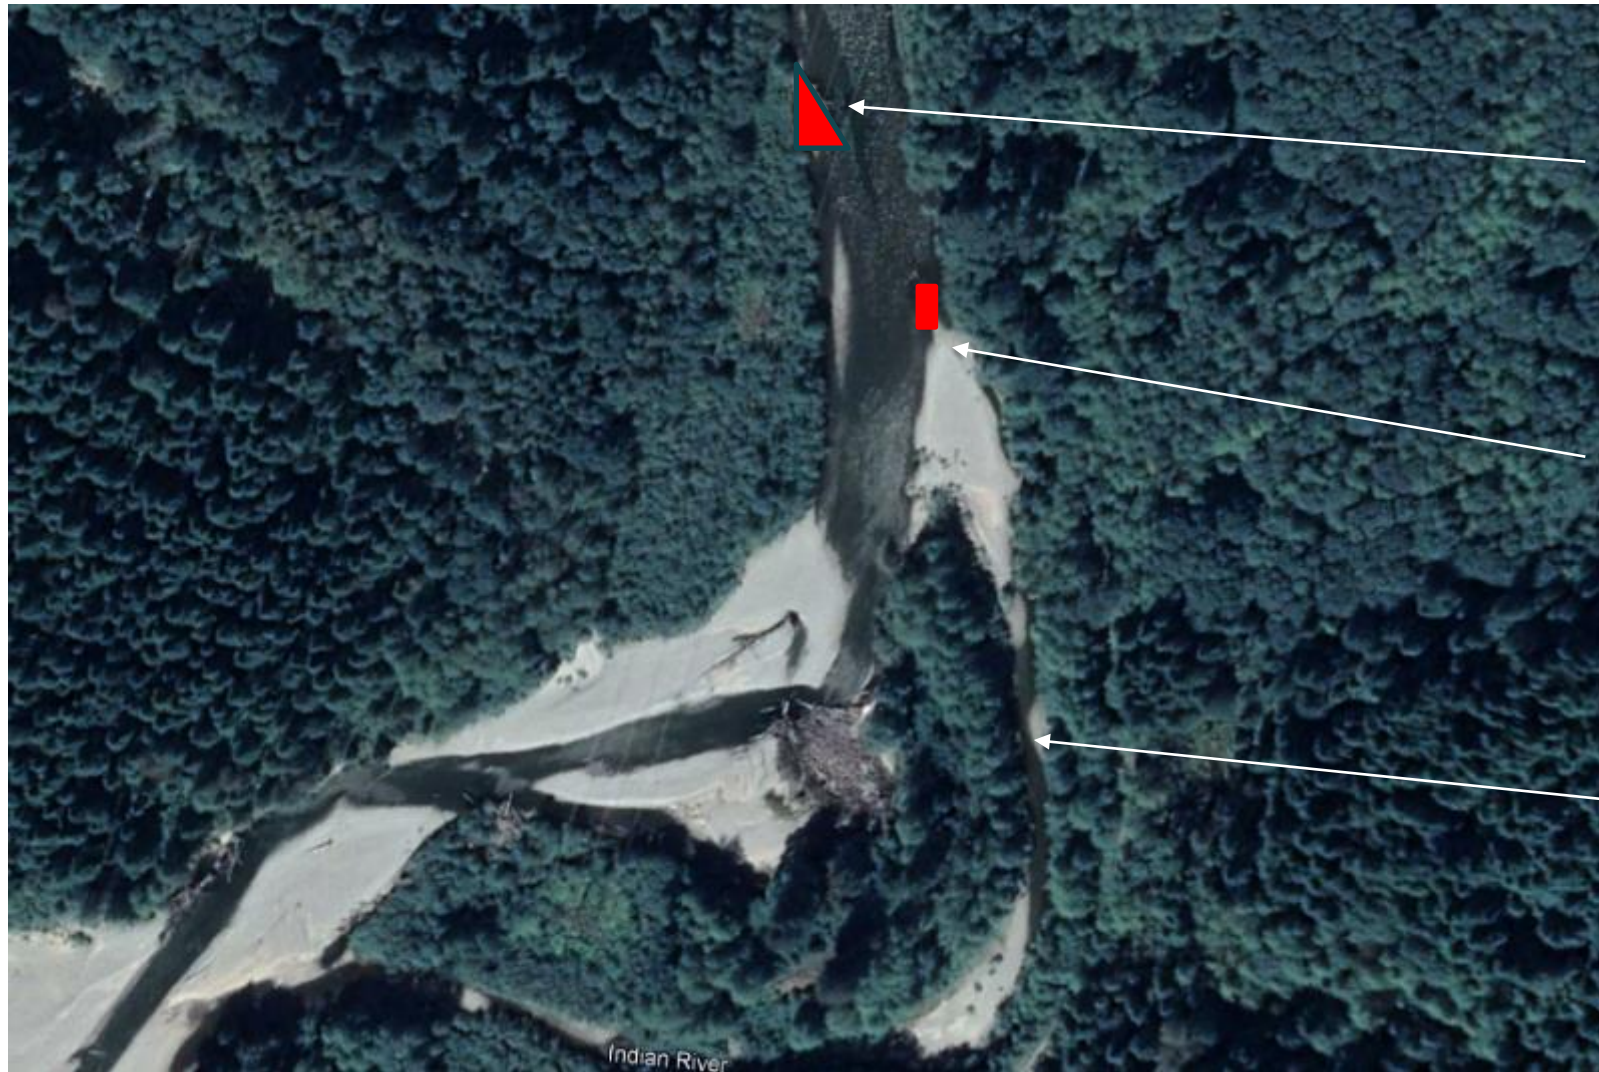
2017 Works

Spur Deflector

Bar Head Jam

Channel Dredging

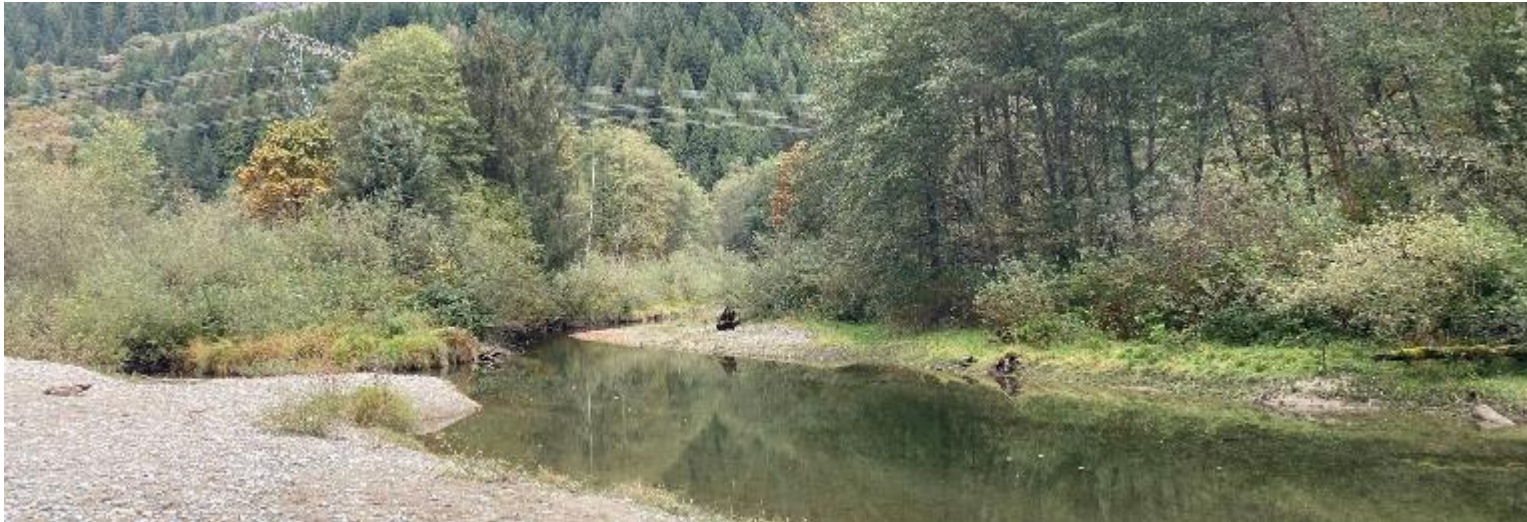
Fall 2017 – High waters

- *Right bank spur – intact but extensive sandblasting of live stakes and loss of fill
- *Bar-head Jam – completely lost, some ballast rock left
- *Channel did not fully re-fill

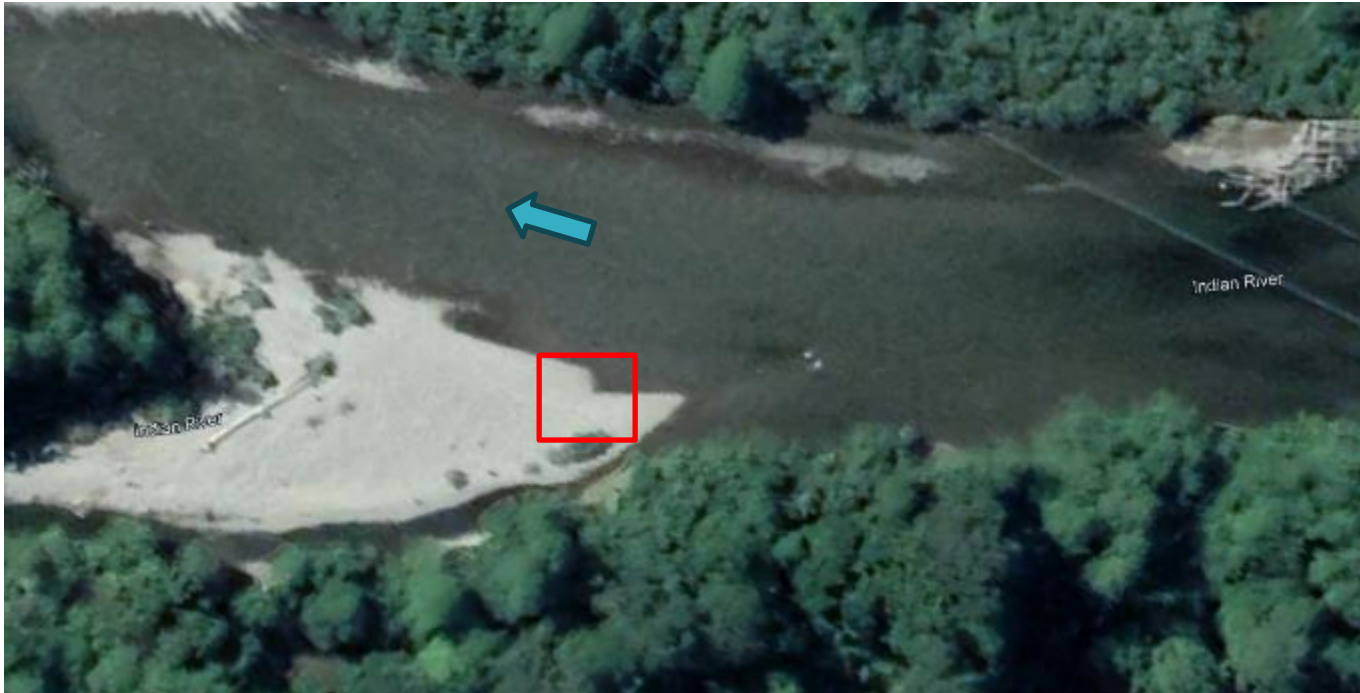
Design Development

- Uncertain design velocities (ungauged system)
- Limited selection of materials
- Remote location
- +very low infrastructure risk
- +good site conditions

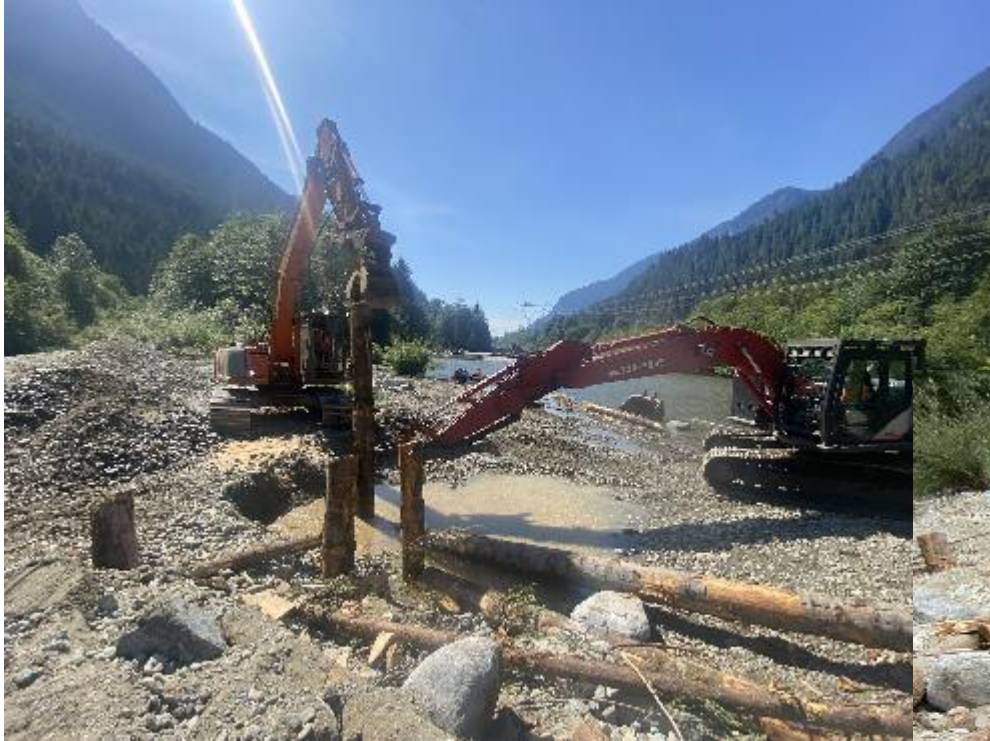
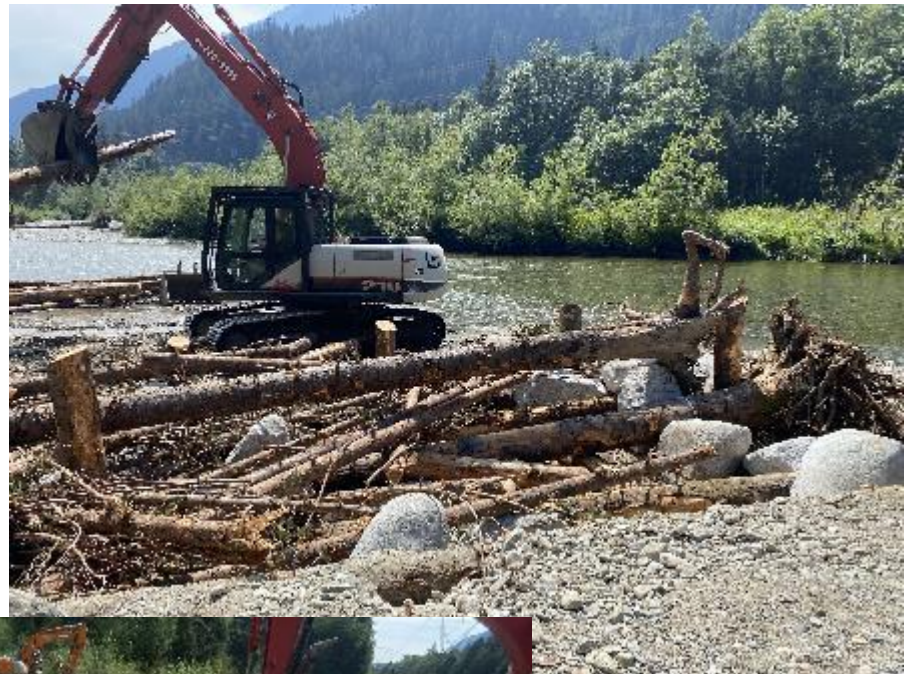
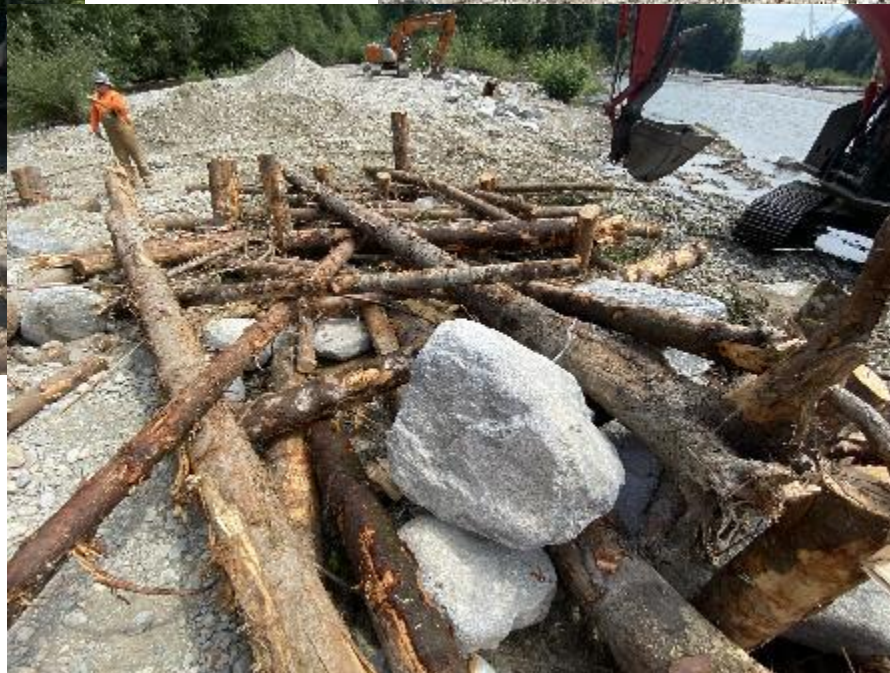
Construction

- 5 Days
- 2 excavators and a rock truck
- Field fitting

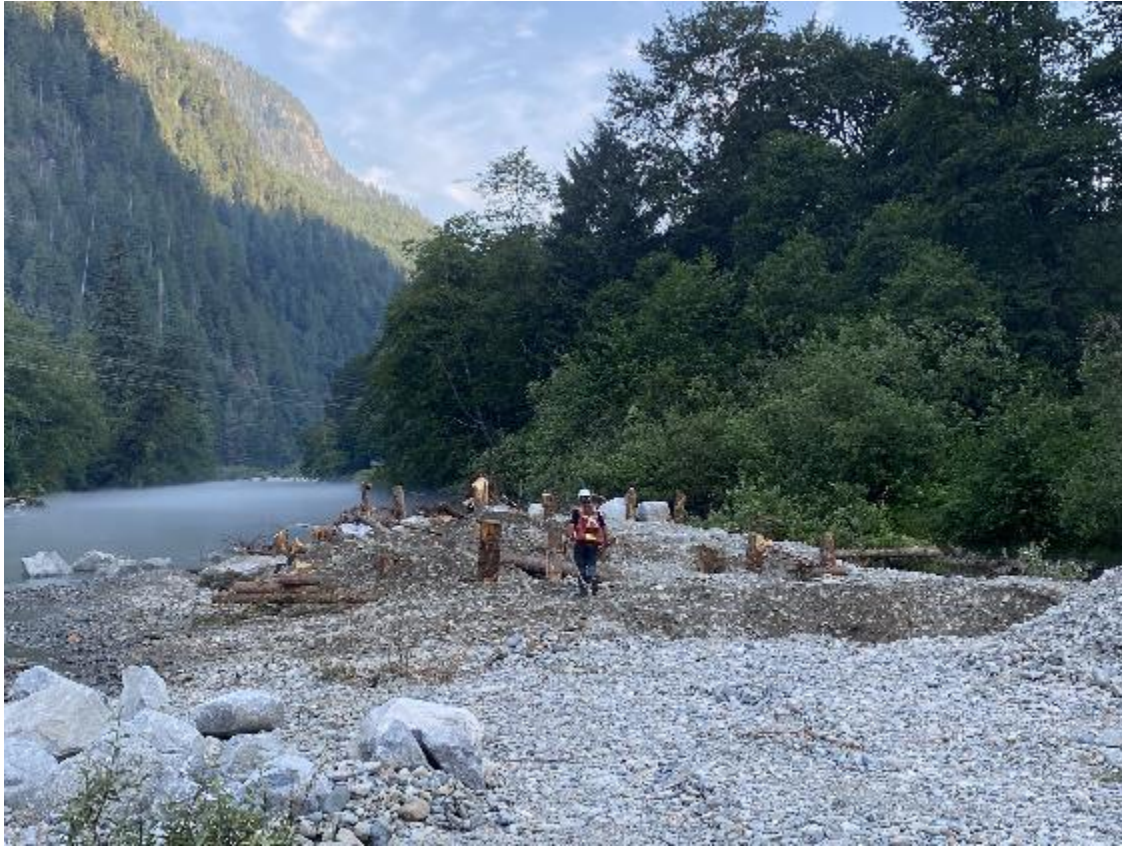
View upstream / north

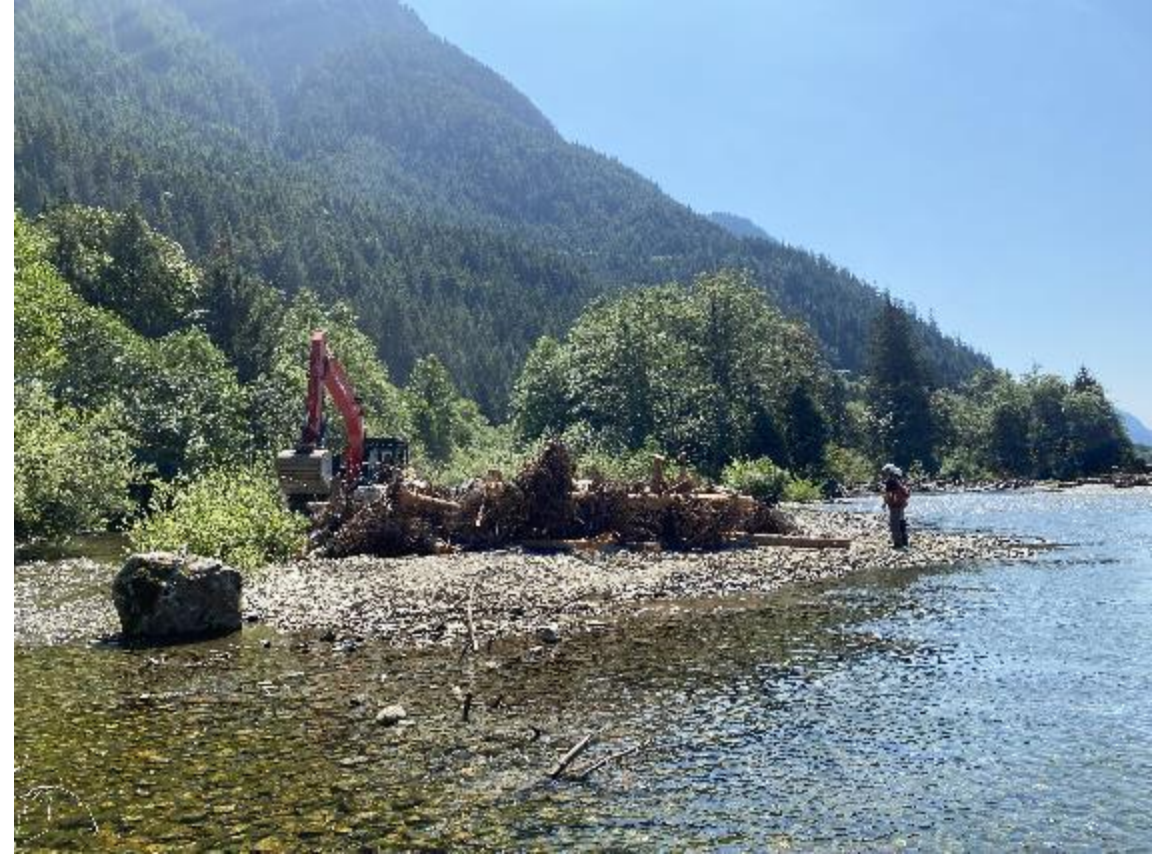
View downstream / south
