# Pocket Estuary Restoration Design and Implementation in the Salish Sea

Jessica Côté, PE Blue Coast Engineering

June 11, 2025

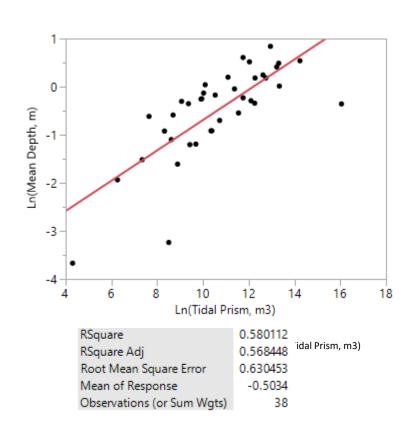
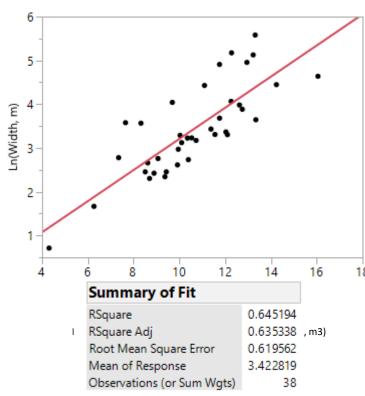
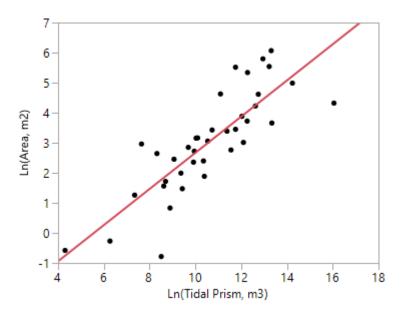
# Regression Analysis – Tidal Prism v2 – All Data

Ln(Area, m2) = -3.344402 + 0.6016819\*Ln(Tidal Prism, m3)

Summary of Fit	
RSquare	0.682151
RSquare Adj	0.673322
Root Mean Square Error	0.964926
Mean of Response	3.032797
Observations (or Sum Wgts)	38

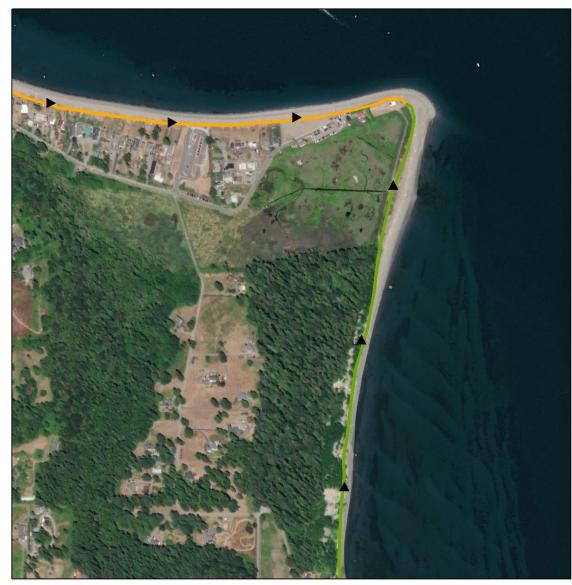
Net Sediment Drift Direction Around Point no Point

Left to Right

No Appreciable Drift
Right to Left

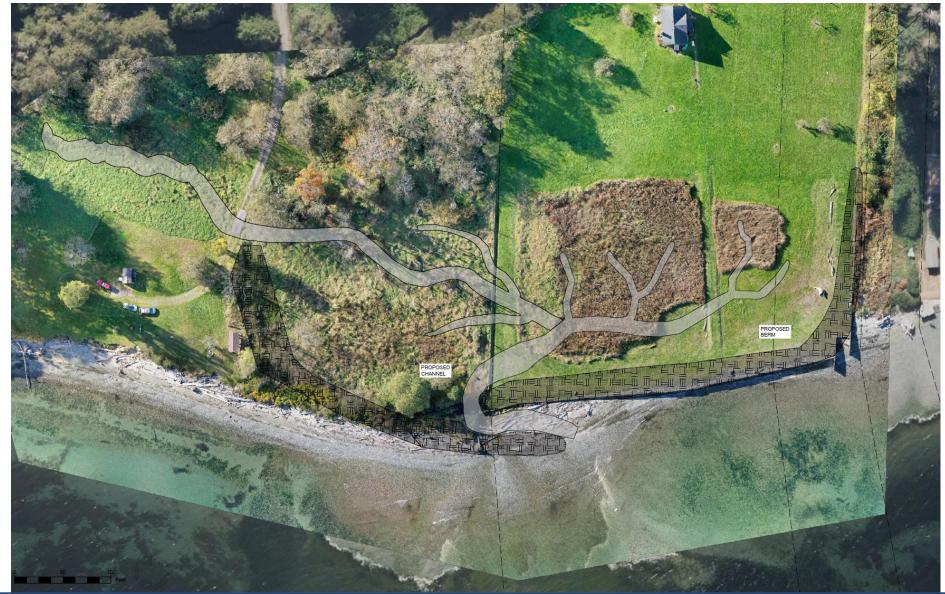
### Rose Point Restoration

- Restore the historic barrier embayment, re-connecting the natural freshwater streamflow to tidal saltwater
- Create fish habitat, particularly for juvenile salmonids
- Remove invasive species and add native plantings
- Educate shoreline landowners about negative effects of shoreline armoring on their properties and encourage removal
