How Resilient Waters Started

Fixing Fraser Floodplains

Joe's Slough Floodgate Replacement Details

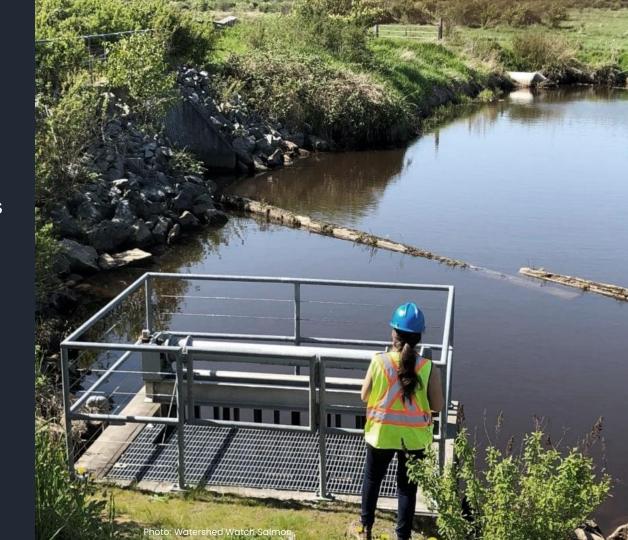
Site Assessments- Fish and WQ at 26 priority sites Report Cards over 3 years

Taylor Road Slough	High Priority		
Type	Slough		
Flood Infrastructure	Top-hinged flood gate (very poor condition)		
Key Rights Holders and Stakeholders	Leg'armel First Nation Private Landowners North Nicomen Improvement District (Dike) Fraser Valley Regional District		
Waterbody Immediately Downstream	Nicomen Slough > Fraser River		
Upstream permanent barrier	Collapsed culvert at crossing		
UTM Coordinates at Mouth	10U 565677 5447690		
Dates visited	March 15-19; June 14-18; August 3-10

- Flood gate is barely functional; gate has been repaired by local farmer and inlet to pipe is almost completely blocked by sediment. Dike is also in poor condition and was further damaged in November 2021 floods.

- Flood gate appears impassable under most conditions although Prickly sculpin and several invasive fish species occur inside the dike.
- . Culvert at farm crossing where reach TR1 and TR2 meet is blocked by beaver and impassable to fish

- · Extensive riparian plantings along south shore
- · Add unanchored large woody debris
- · Assess opening connection with TR3 under farm crossing

- Excavate accumulated sediment from pond where accessible with excavator.
- · Add unanchored large woody debris
- Replace culvert culverts under farm crossing with beaver proof guarded culvert
- · Extensive riparian plantings on both banks, maintaining a view of pond from house

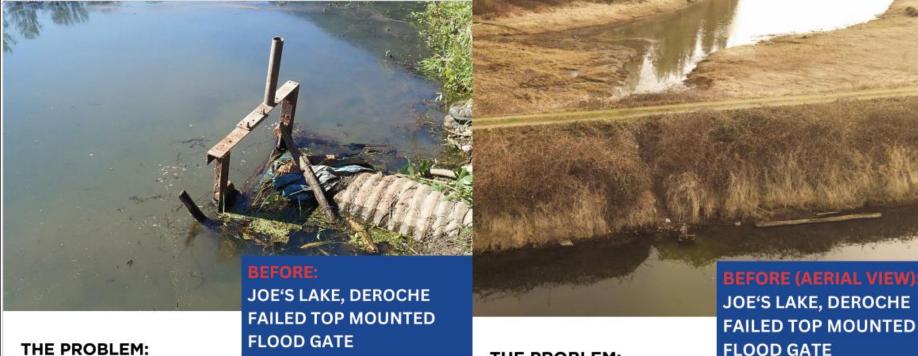
- Unable to handle projected water increase from climate change
- Collects debris and garbage
- Prevents fish access to critical overwintering habitat

THE PROBLEM:

- Disconnected water flow creates higher water temperatures - fatal to salmon
- Restricted water flow causes decreased water quality, promoting the growth of invasive species and plant populations

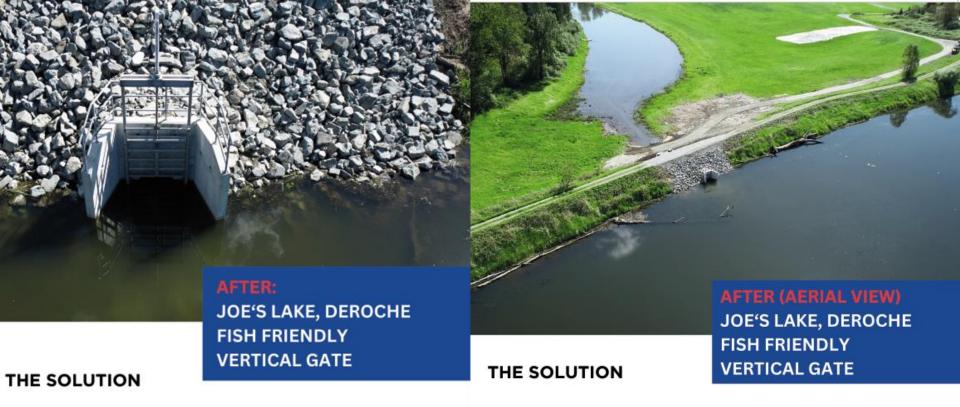
- When flood risk is high, gate closes to protect the community
- Reduced flood risk helps to ensure food security for the community
- Improved water flow and exchange prevents growth of algae and invasive plant populations
- Increased wetland habitat for juvenile salmon, waterfowl and ecological resilience

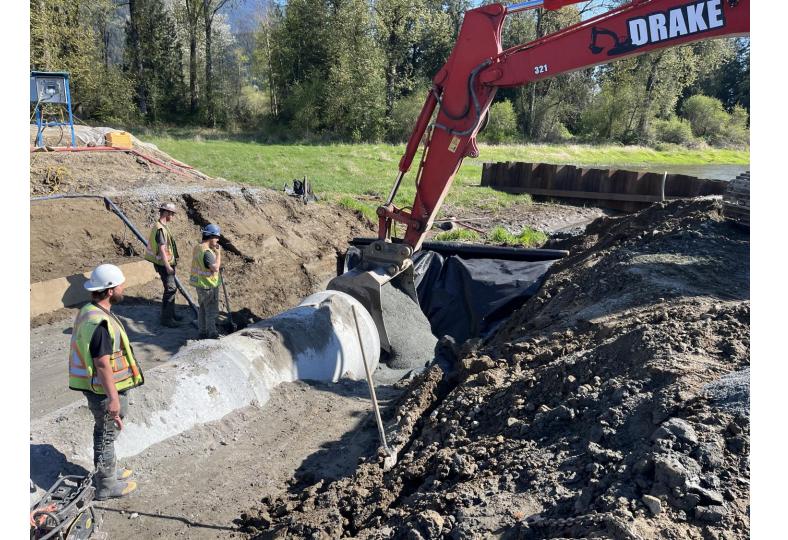
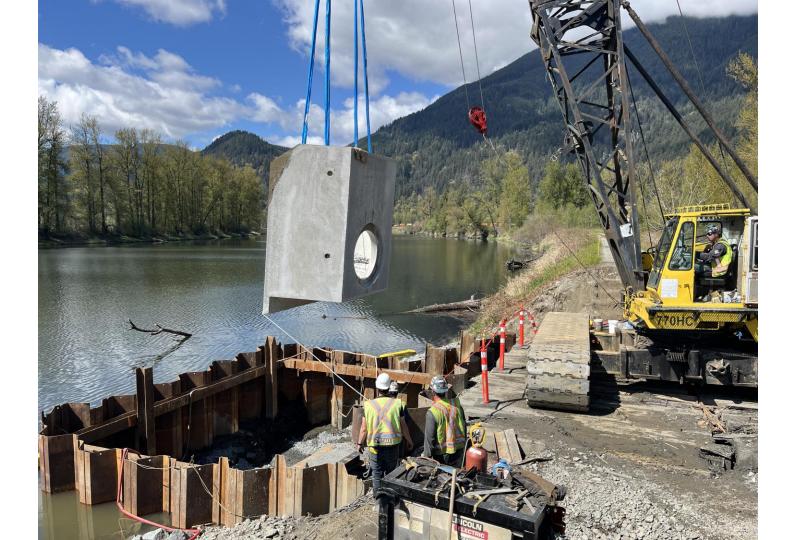
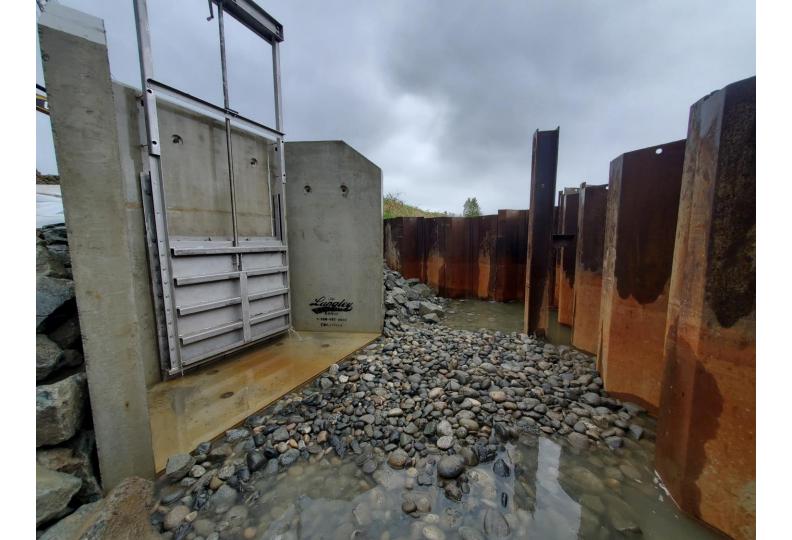
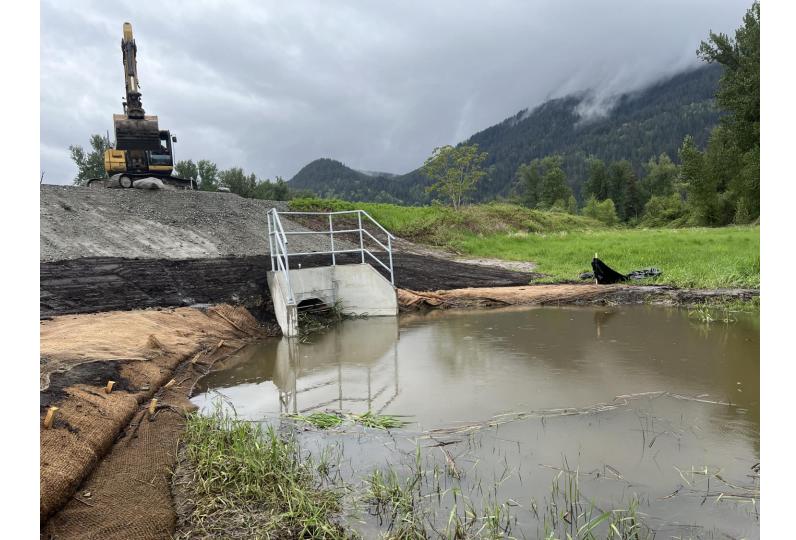
- Timeline ~ 4 years from funding application to construction completion
- Installed spring 2024, automated summer 2025 (solar panel / battery + controller)
- Cost = \$1 million
 - \$200K pre-construction (meetings, feasibility and modeling, engineering design, permitting) +
 - \$800K construction mainly cuz it involved ripping a dike apart and putting back together
 - o Many dikes were constructed in late 1800's or early 1900's by farmers, never know what you'll get
- Opened 5 hectares of slough habitat in high salmon value area Coho, Chum,
 Chinook, potential for further future connections
- Multi-partner effort / table that has led multi-million \$ funding restoration in the area
- Funded by BC Salmon Restoration Innovation Fund, Pacific Salmon Foundation,
 Bonneville Environment Fund
